# The Stava catastrophic failure of July 19, 1985 (Italy): technical-scientific data and socioeconomic aspects

Lucia Simeoni<sup>1</sup>, Giovanni Tosatti<sup>2</sup>, Graziano Lucchi<sup>3</sup>, Michele Longo<sup>4</sup>

*On July 19, 1985 at Stava near Tesero (Trento Region, northern Italy), two impoundments collapsed, causing the death of 268 people and the destruction of many buildings. The two adjacent basins were constructed for the decantation and storage of fine-grained waste material (tailings), which was pumped from a nearby fluorite mine. The consequences of the failure was a vast mudflow that found its way downstream along the Stava valley. The failure occurred as a result of the collapse of the upper basin, which overwhelmed the lower basin. The mudflow continued down the valley destroying many houses in the village of Stava, eventually reaching Tesero, where more property was destroyed or severely damaged. The disaster in the Stava valley was one of the most tragic of its kind. With its high toll of lives lost and over 133 million euros in damage, it was one of the worst industrial catastrophes anywhere in the world. This paper examines the technical errors, shortco

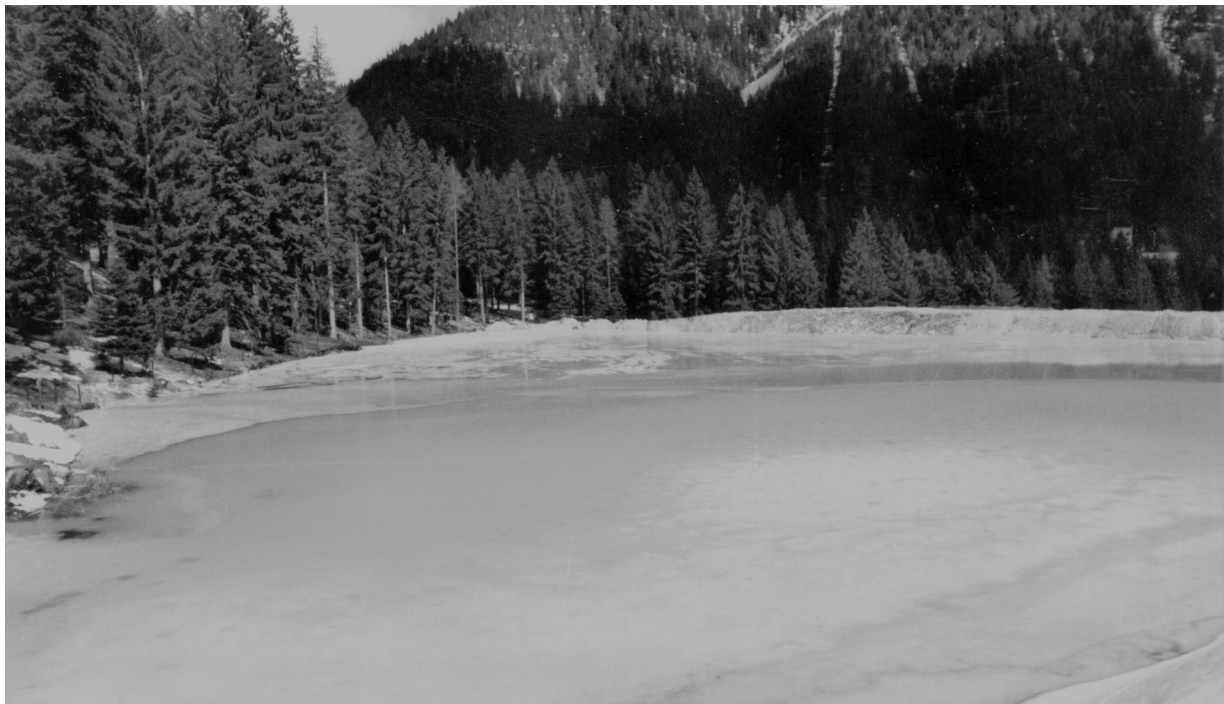
Figure 2 – The lower Stava basin in April 1985.

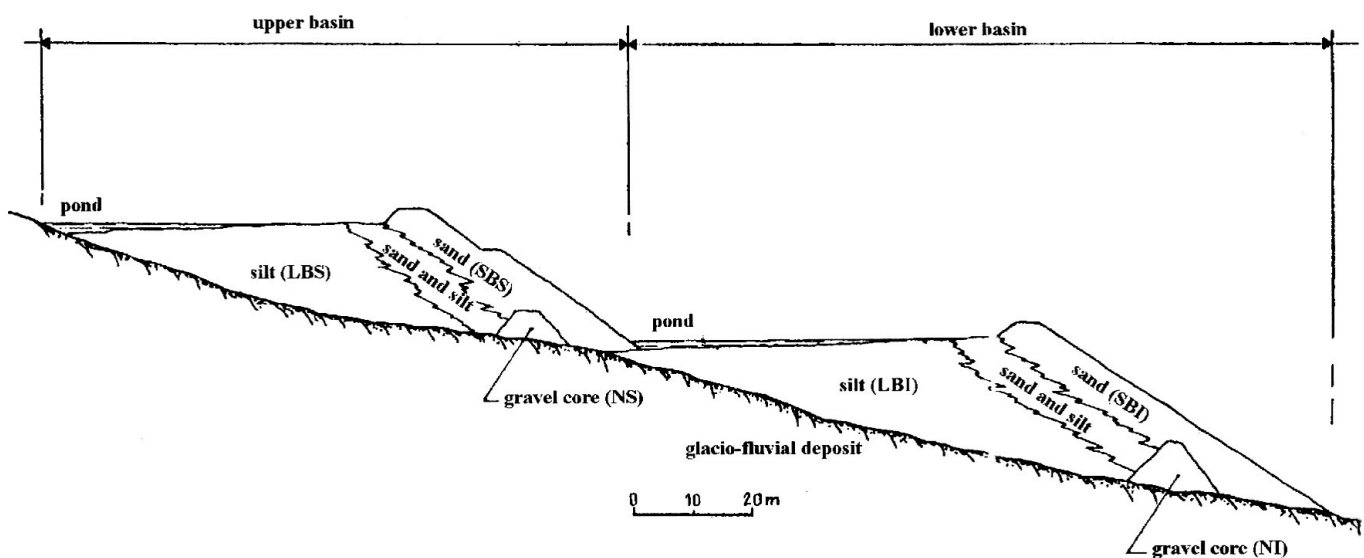
Figure 4 – Section sketch of the Stava tailings dams (after Colombo, and Colleselli 2003).

When failure occurred, the lower dam was 25 m high and the upper dam was over 34 m high. Together, they made up an earth structure nearly 60 m high. The upper dam had a berm

at about 2/3 from its base, which partially rested on the silt of the lower dam. The upper dam's slope was  $38^{\circ}\pm 39^{\circ}$  below the berm and about  $32^{\circ}$  above the berm (Fig. 4).

the light of the monitoring results and stability analyses. Raised embankments can be constructed using upstream, downstream, or centerline methods (Fig. 6). With the upstream method, the embankment axis moves backwards and the beach that develops during the deposition of the tailings becomes the foundation of the next dam. With the centerline method, the coarse part of the tailings is placed on both the beach and the downstream face. The upstream method was used in Stava to raise the embankments of both the lower and the upper basins. For the lower basin (built from 1961 to 1971), it was used alternately to the centerline method, while for the upper basin (built from 1969 to 1985) the upstream method was adopted after an initial construction stage using the centerline method (Colombo, and Colleselli 2003). It follows that initially the upper basin was partially founded on the inner, and then finer, part of the tailings of the lower basin (Fig. 4).

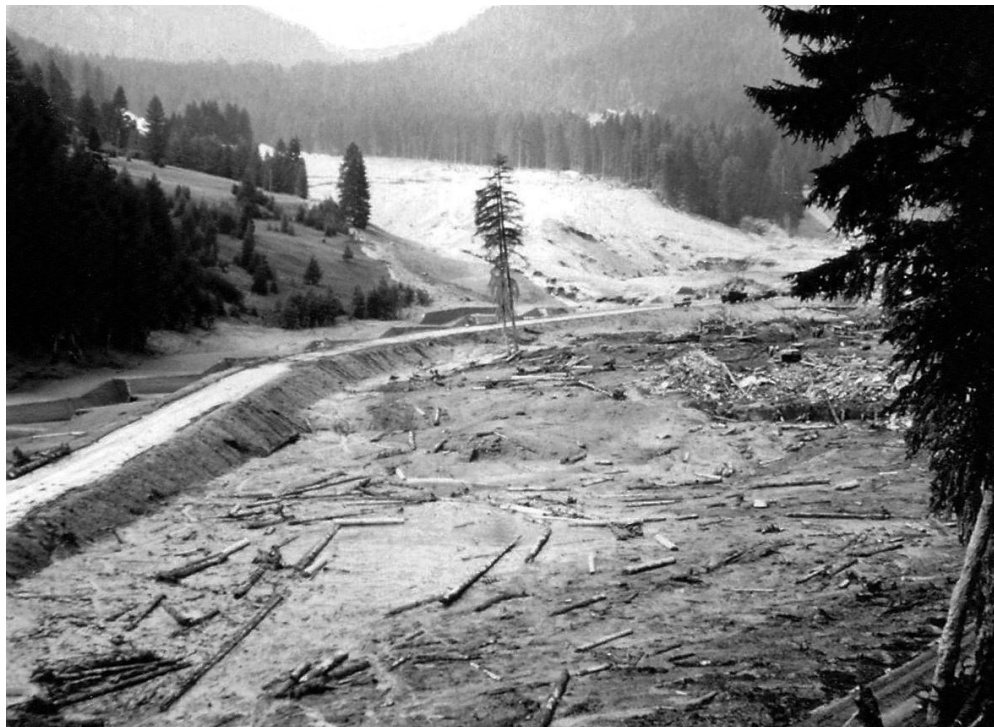
Figure 5 – The devastating effects of the flowslide on the Stava valley (July 1985)

2003). Hundreds of trees were broken or uprooted because of the air blast that preceded the flowslide (Fig. 5). Along its route, the flowslide caused the death of 268 people, the complete destruction of 53 houses, three hotels, six industrial buildings and eight bridges, seriously damaging several other buildings. Of the two bridges of Tesero, the first was overflowed and damaged by the flowslide, although it stood 16 m high over the valley floor. Total damage amounted to over 133 million euros (Lucchi 2011).

Both dams were poorly built with inhomogeneous materials, with the upper tailings dam resting on the unconsolidated silt of the lower basin. In addition, the overflow and decant pipes had been wrongly placed inside the upper basin and sagged under the increasing weight of the silty deposits, causing significant leaks inside the pond (Fig. 7). Finally, proper stability analyses were never carried out and the soil's susceptibility to failure-induced liquefaction was completely ignored, notwithstanding the good level of technical knowledge that was available from literature (Luino, Tosatti, and Bonaria 2014). In this way, when failure occurred, there was a very fast, destructive flowslide, leaving no chance of escape to whoever was in its course (Fig. 5).

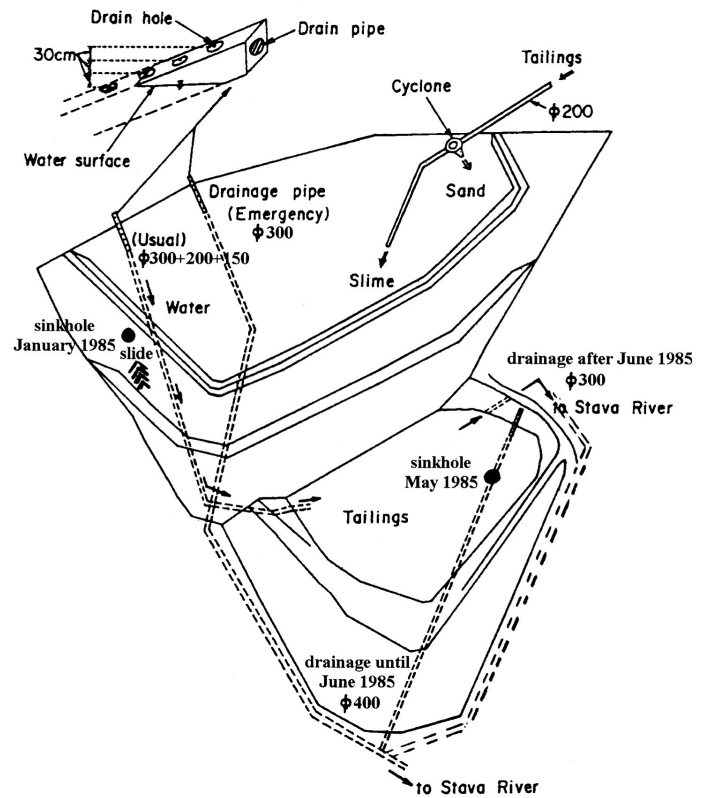
Figure 7 - Location of the decant pipes through the Stava dams (Colombo, and Colleselli 2003).

Consolidation of tailings can be improved by providing adequate internal drainage. At Stava, water drain pipes were used for the two impoundments (Fig. 7), but they proved to be inadequate and dangerous for stability. In fact, early in 1985, two failures were caused by the malfunctioning of the decant pipes at the toe of the right bank of the upper basin (January 1985) and in the left bank of the lower basin (May 1985). Moreover, pore-water pressure measurements carried out in the foundation deposit after the disaster indicated that pressure increased in the rainy period. Therefore, it is likely that in some periods, especially in spring and the beginning of summer (when precipitation is maximum, cf. Fig. 8), the foundation soil was not able to drain but, on the contrary, water was seeping upward in the tailings and in the embankments reducing their safety.

Finally, the overflow and decant pipes had been wrongly placed inside the basins and they sagged under the increasing weight of the silt deposits. This caused significant leaks inside the ponds in two different circumstances, early in 1985, when substandard repairs were carried out. This last mismanagement of the drainage system inside the upper basin is considered to be the triggering cause of its eventual failure (Chandler, and Tosatti 1995).

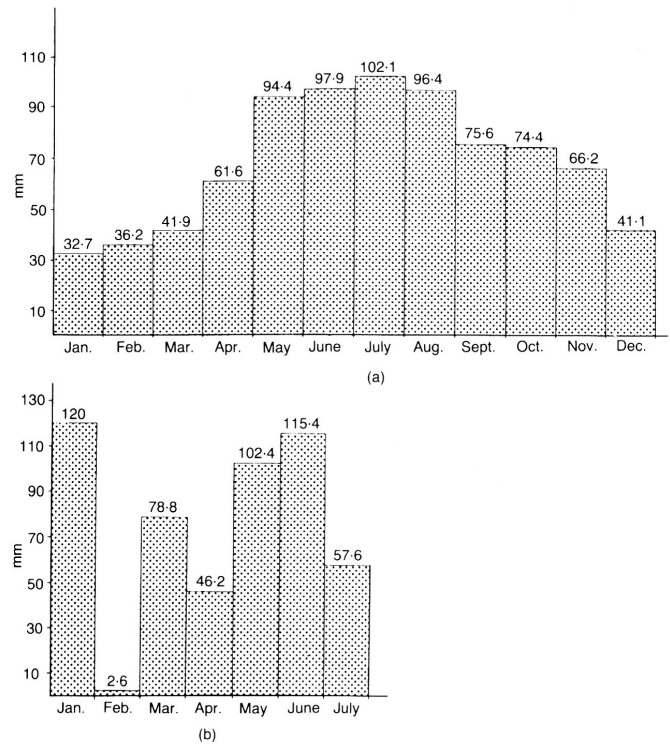
Figure 8 – (a) Mean monthly precipitation at Cavalese gage, near Stava, 1921-1987; (b) precipitation from January 1985 to July 19, 1985.

From a meteorological point of view, the mean annual precipitation in the area studied is 820 mm. This value corresponds to the 1921-1987 observation period and was measured at the Cavalese weather gage, located at about 4 km SW of Stava at an altitude of 990 m. Fig. 8 shows the trend of the mean monthly precipitation and points out that the maximum rainfall is concentrated between May and August. Since the annual mean temperature is about 7 °C, the real evapotranspiration according to Turc should correspond to 52% of the year total precipitation in the period considered. With reference to the precipitation of the year 1985 (Fig. 8), when the dams' failure occurred, it can be noticed that the precipitation in the first six months was 465 mm, compared with the general mean value of 365 mm. In particular, in June of the same year the rainfall was 115 mm, compared with a mean value of 98 mm.

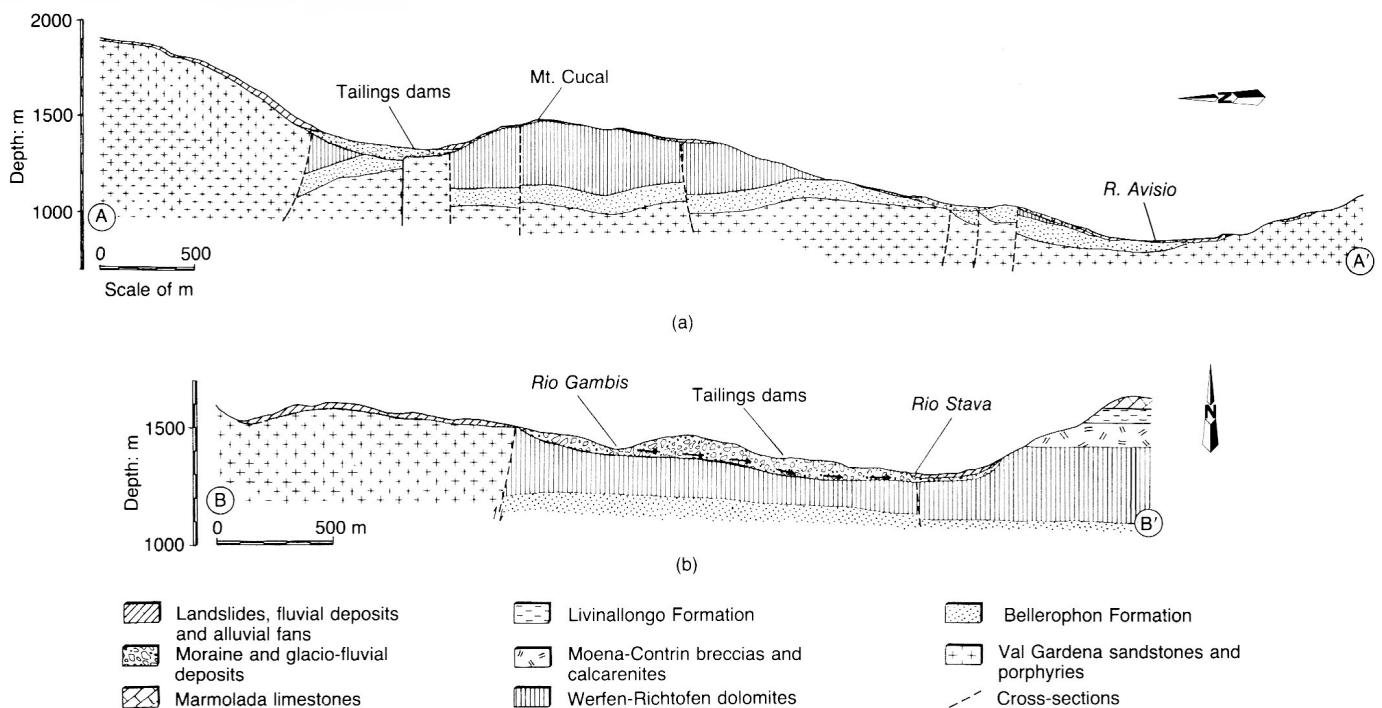
Figure 9 – Geological cross-sections across the failure area at Stava (after Chandler, and Tosatti 1995).

recent geological investigations (Various Authors 2017), it was possible to construct the two sections illustrated in Fig. 9. It is interesting to note, in section B – B', that there appears to be physical continuity in the moraine cover between the deposits of the nearby Rio Gambis valley and those of the Stava valley through a pre-Quaternary buried channel beneath the Rio Porcellini stream.

These data can be explained if the geometrical and structural characteristics proposed in the geological sections of Fig. 9 are accepted. According to this interpretation, there is a water circulation from the Gambis valley into that of the Rio Porcellini, resulting in the emergence of the Pozzole springs, where the tailings dams stood.
