# CSE

## City Safety Energy

ISSN 2283-8767 [www.csejournal.net](http://www.csejournal.net) - ISSUE 1 | January - December 2017 | Semiannual publication

# The Stava catastrophic failure of July 19, 1985 (Italy): technical-scientific data and socioeconomic aspects

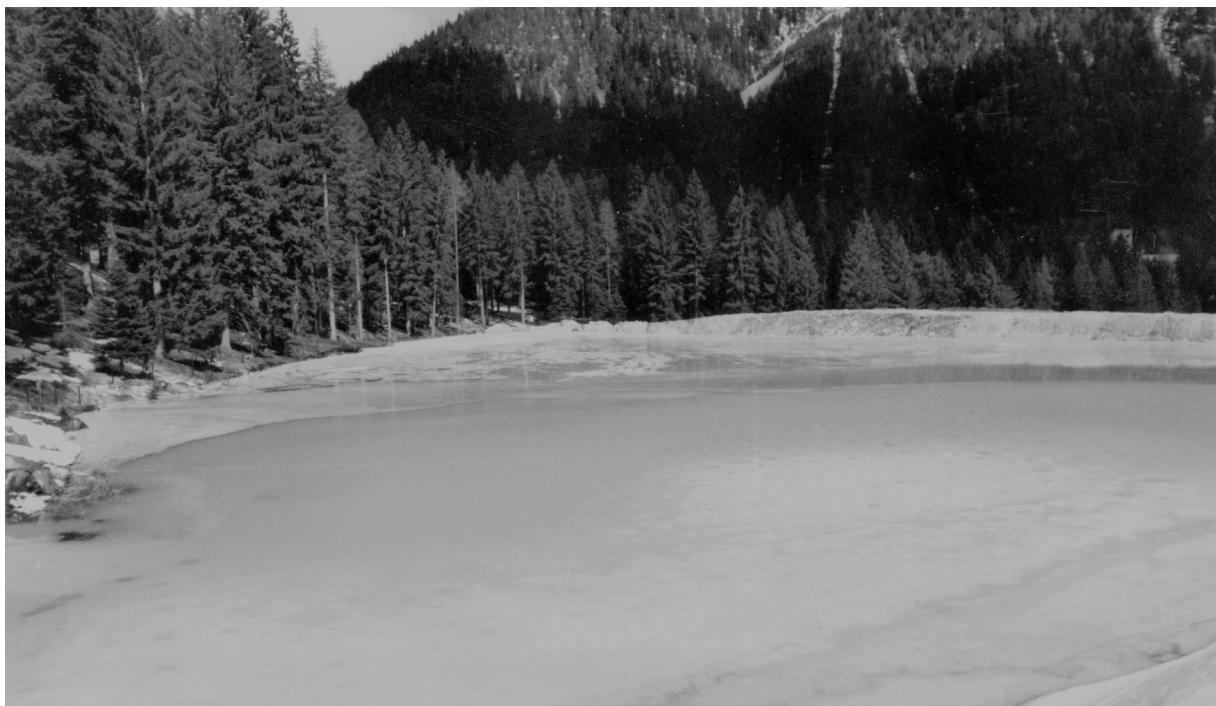
Figure 2 – The lower Stava basin in April 1985.

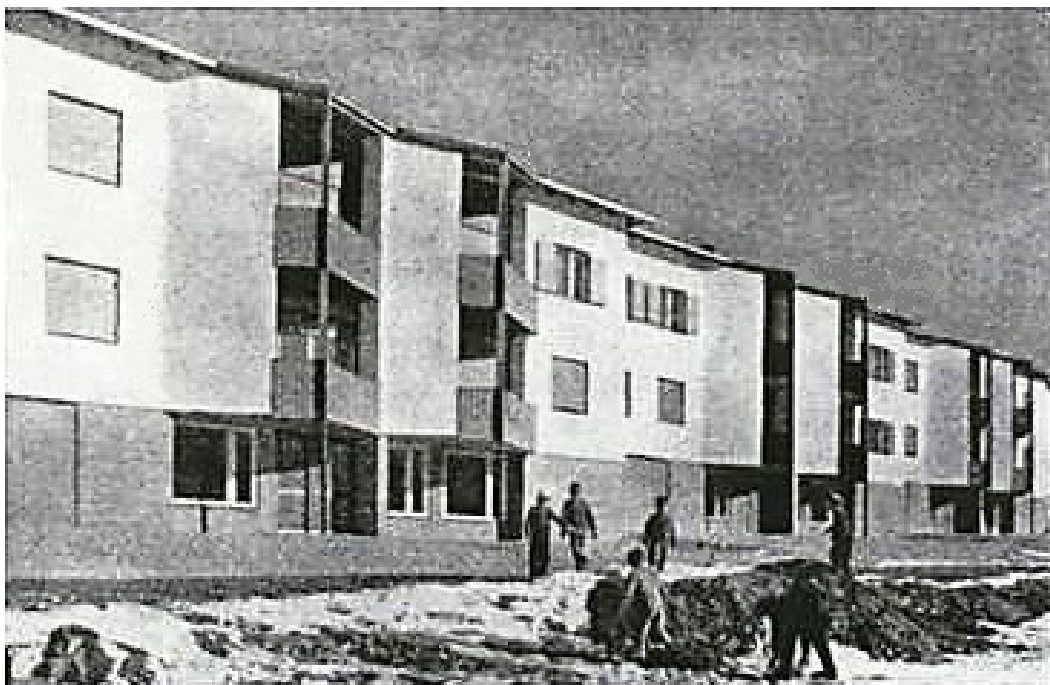
Figure 3 – The accommodation facilities for the mineworkers in Tesero (early 1960s).

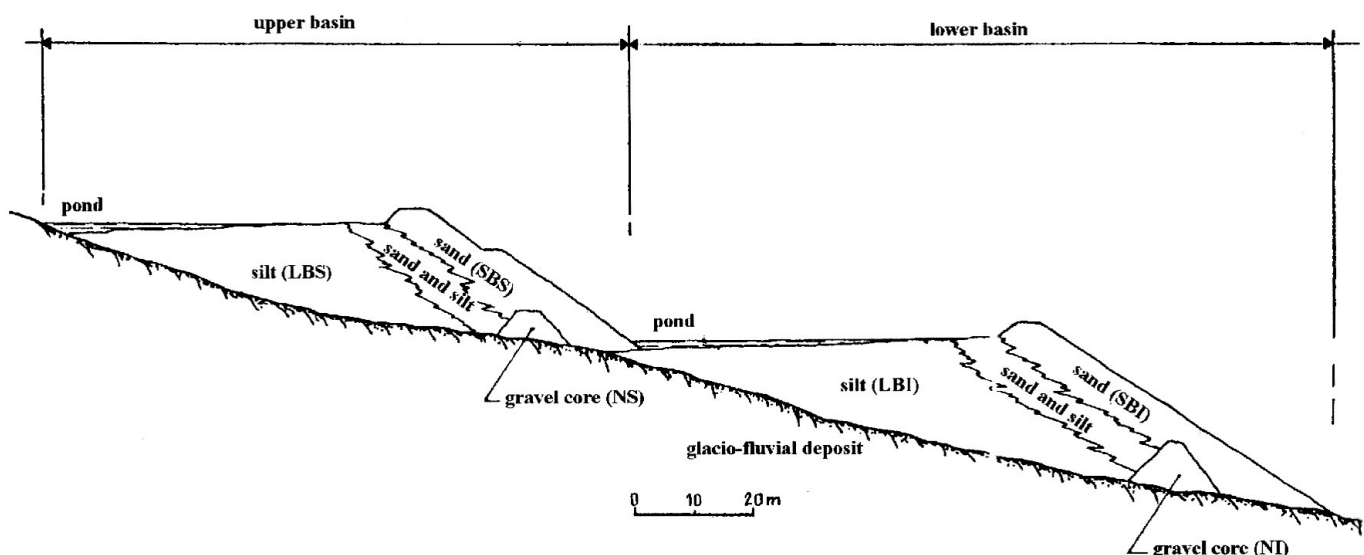
Figure 4 – Section sketch of the Stava tailings dams (after Colombo, and Colleselli 2003).

The upstream method was used in Stava to raise the embankments of both the lower and the upper basins. For the lower basin (built from 1961 to 1971), it was used alternately to the centerline method, while for the upper basin (built from 1969 to 1985) the upstream method was adopted after an initial construction stage using the centerline method (Colombo, and Colleselli 2003). It follows that initially the upper basin was partially founded on the inner, and then finer, part of the tailings of the lower basin (Fig. 4).

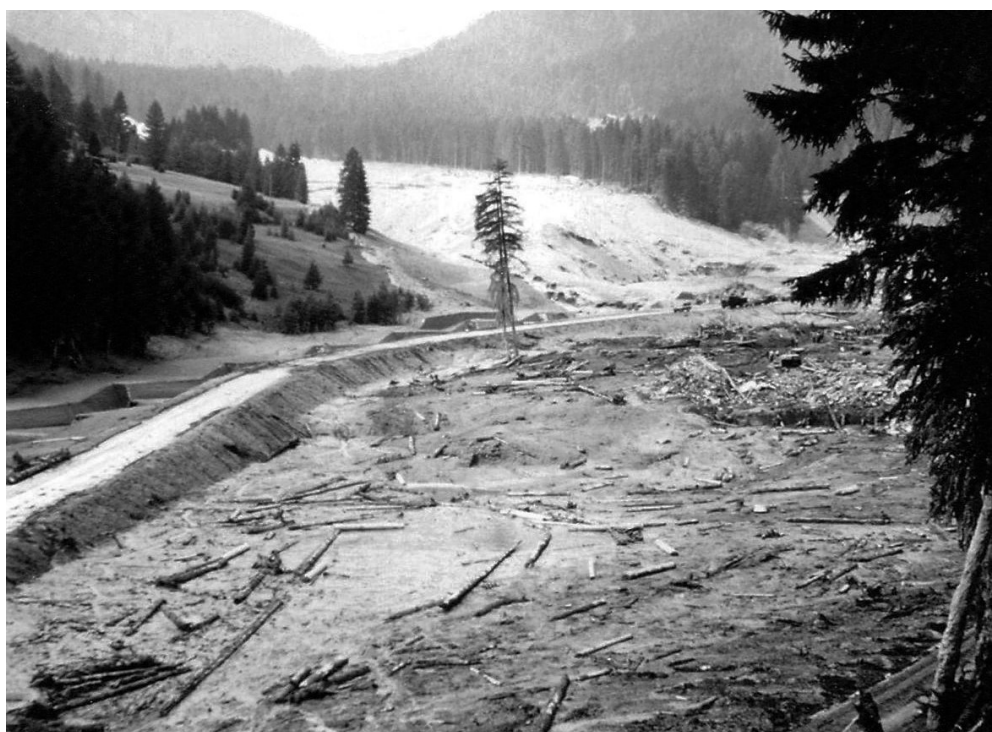
Figure 5 – The devastating effects of the flowslide on the Stava valley (July 1985)

2003). Hundreds of trees were broken or uprooted because of the air blast that preceded the flowslide (Fig. 5).

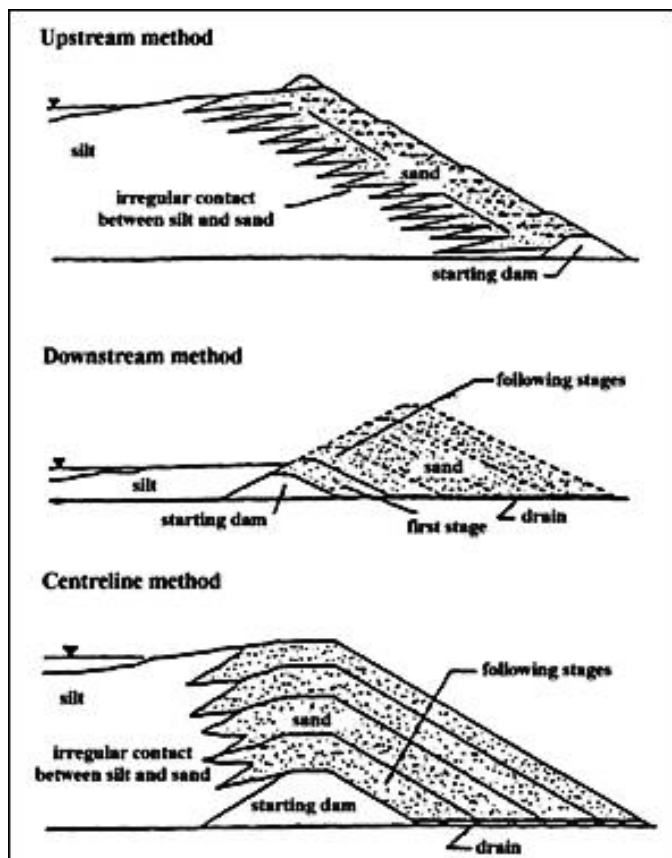
Figure 6 – Construction methods of tailings dams (after Colombo, and Colleselli 2003).

the light of the monitoring results and stability analyses. Raised embankments can be constructed using upstream, downstream, or centerline methods (Fig. 6). With the upstream method, the embankment axis moves backwards and the beach that develops during the deposition of the tailings becomes the foundation of the next dam. With the centerline method, the coarse part of the tailings is placed on both the beach and the downstream face.

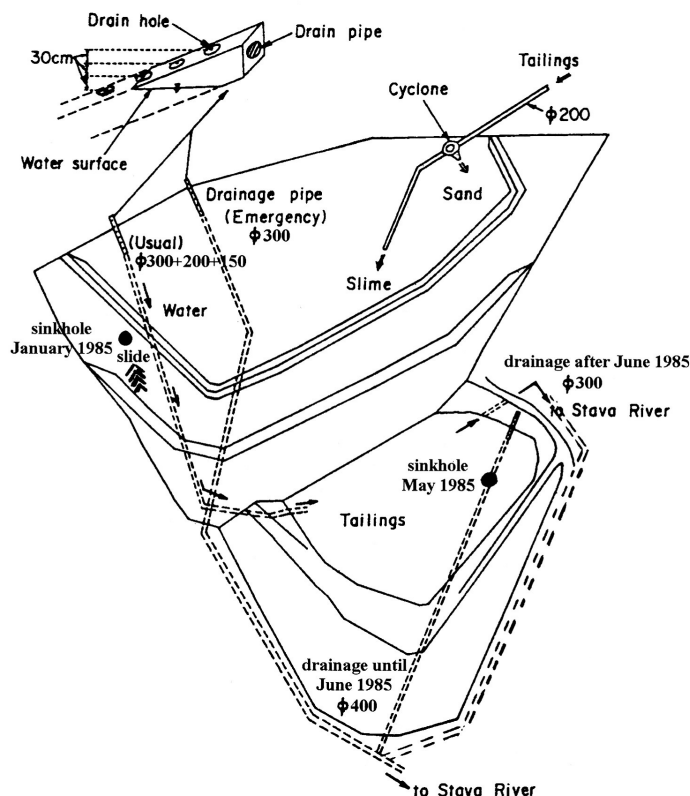
Figure 7 – Location of the decant pipes through the Stava dams (Colombo, and Colleselli 2003).

Consolidation of tailings can be improved by providing adequate internal drainage. At Stava, water drain pipes were used for the two impoundments (Fig. 7), but they proved to be inadequate and dangerous for stability. In fact, early in 1985, two failures were caused by the malfunctioning of the decant pipes at the toe of the right bank of the upper basin (January 1985) and in the left bank of the lower basin (May 1985). Moreover, pore-water pressure measurements carried out in the foundation deposit after the disaster indicated that pressure increased in the rainy period. Therefore, it is likely that in some periods, especially in spring and the beginning of summer (when precipitation is maximum, cf. Fig. 8), the foundation soil was not able to drain but, on the contrary, water was seeping upward in the tailings and in the embankments reducing their safety.

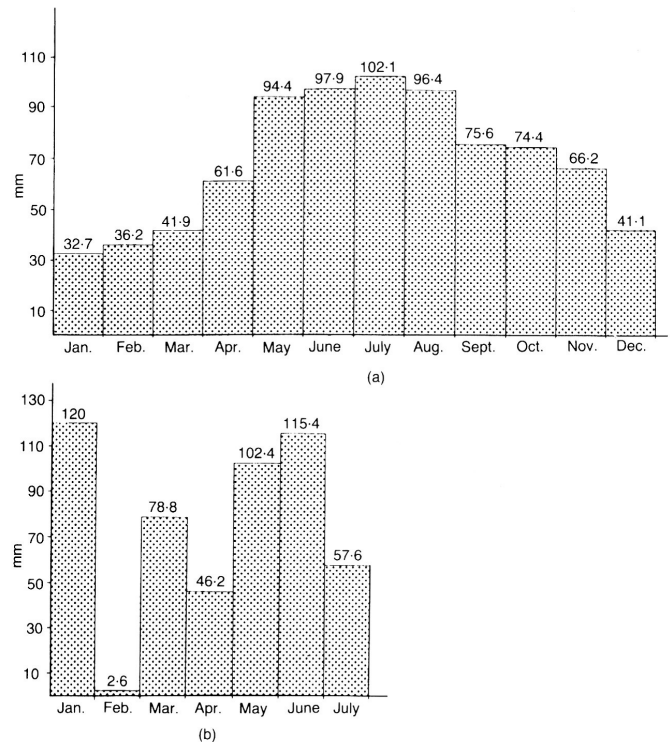
Figure 8 – (a) Mean monthly precipitation at Cavalese gage, near Stava, 1921-1987; (b) precipitation from January 1985 to July 19, 1985.

From a meteorological point of view, the mean annual precipitation in the area studied is 820 mm. This value corresponds to the 1921-1987 observation period and was measured at the Cavalese weather gage, located at about 4 km SW of Stava at an altitude of 990 m. Fig. 8 shows the trend of the mean monthly precipitation and points out that the maximum rainfall is concentrated between May and August. Since the annual mean temperature is about 7 °C, the real evapotranspiration according to Turc should correspond to 52% of the year total precipitation in the period considered. With reference to the precipitation of the year 1985 (Fig. 8), when the dams' failure occurred, it can be noticed that the precipitation in the first six months was 465 mm, compared with the general mean value of 365 mm. In particular, in June of the same year the rainfall was 115 mm, compared with a mean value of 98 mm.

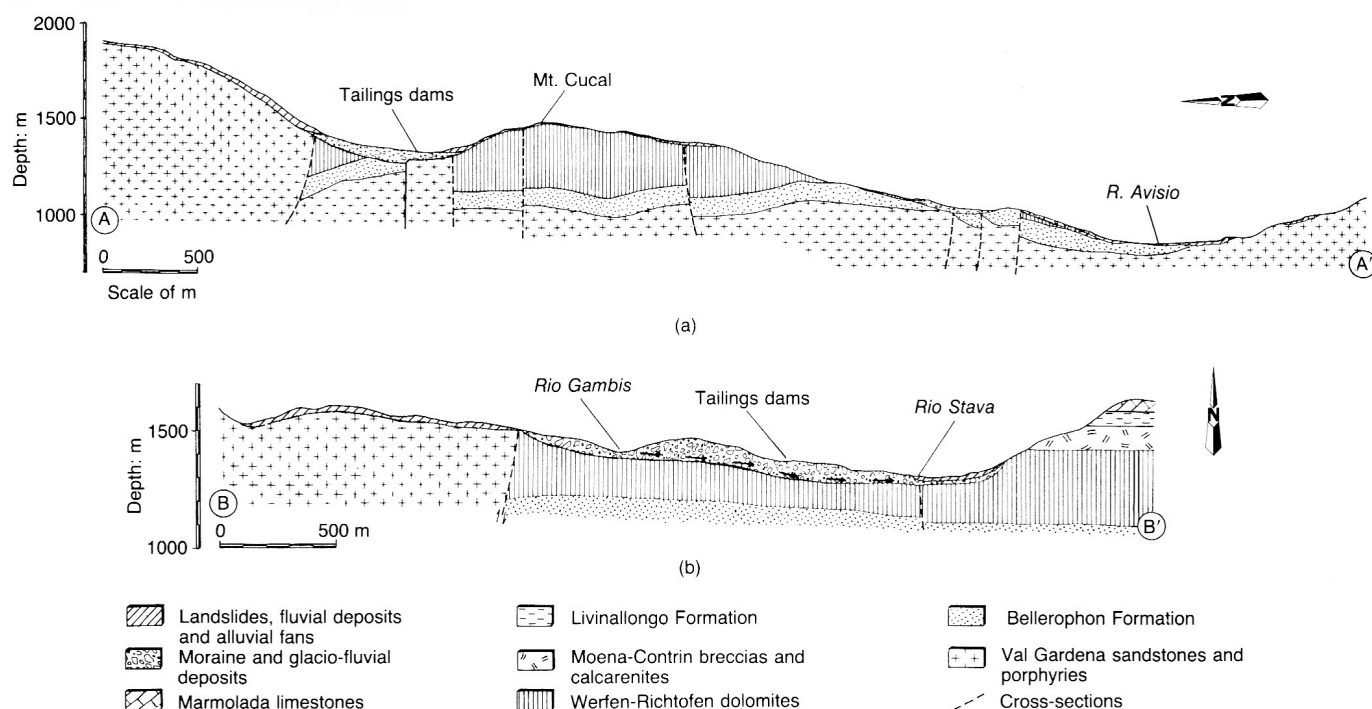
Figure 9 – Geological cross-sections across the failure area at Stava (after Chandler, and Tosatti 1995).

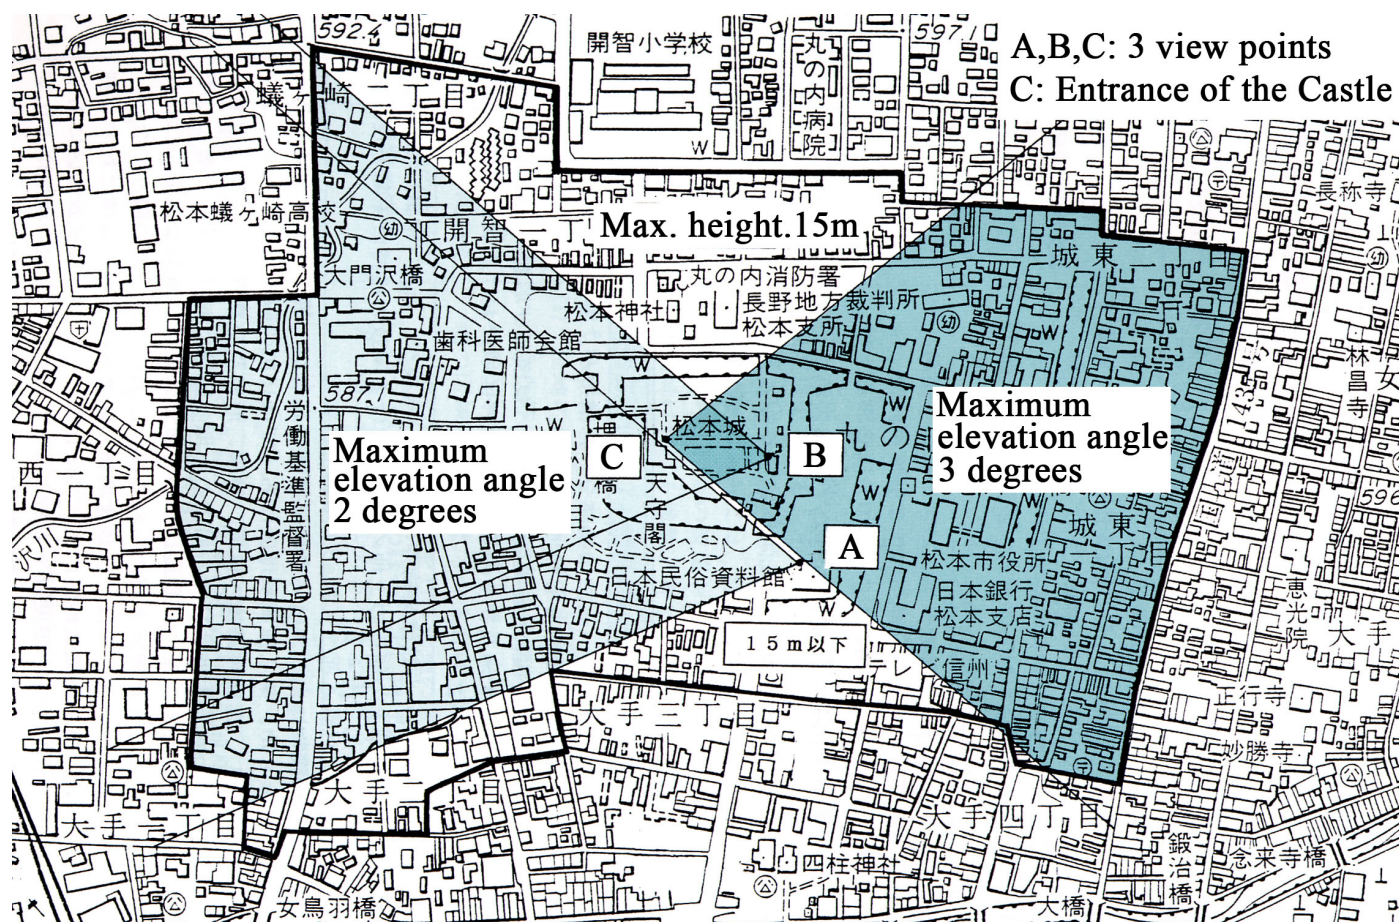
Figure 1 – Three view protection areas, reported by Prof Sachio Otani of the University of Tokyo, for the view protection at Matsumoto castle, in 1973 (reproduction in 1986). Credit: Matsumoto City.

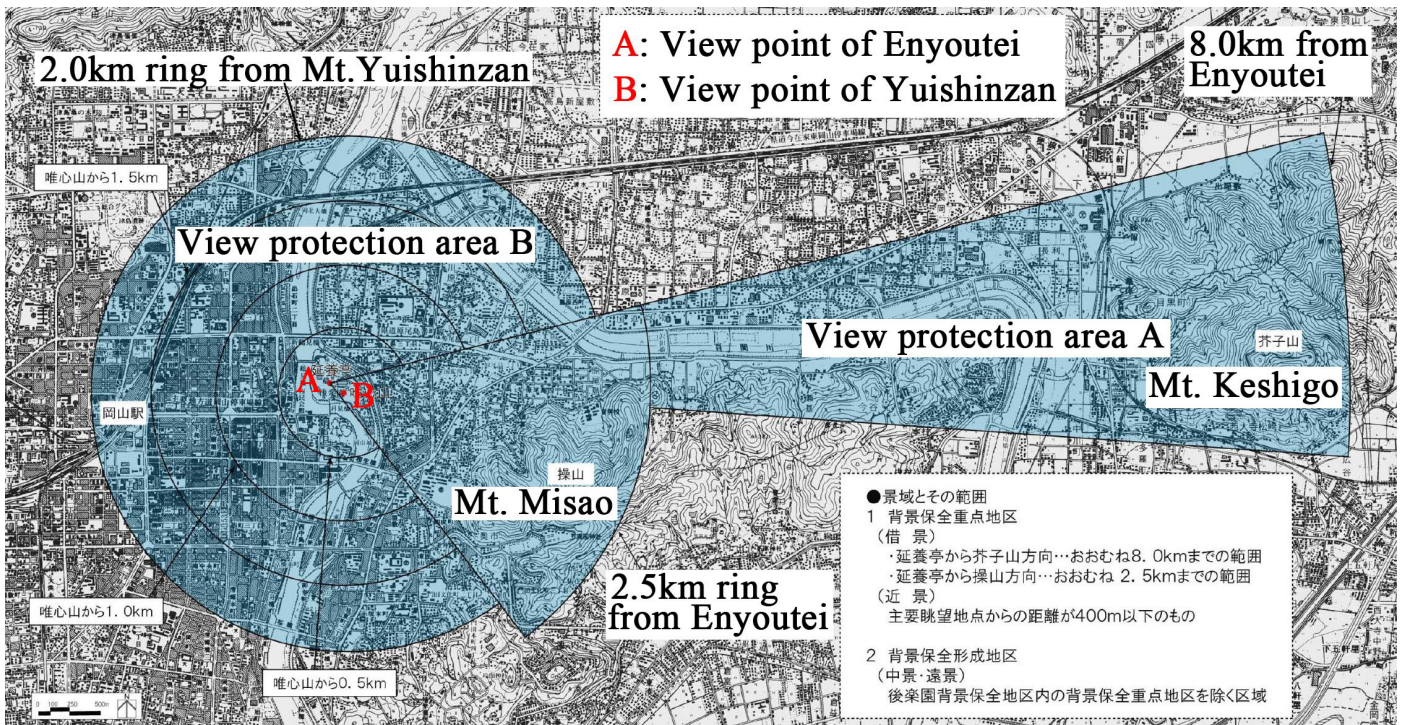
Figure 3 – Two view protection areas designated by Okayama Prefecture with the landscape ordinance in 1992. The view-point of Enyoutei (A) reveals the view from the villa in the Japanese garden 'Korakuen', established in 1700. The longest view measures 8 km till Mt. Keshigo which is outside the garden but the view was originally designed from the garden. The other viewpoint of Yuishinzan (B) shows the view from the small mount in the garden. The view measures 2 km in the central area of Okayama City. The two view protection areas were adopted in the landscape plan of Okayama City by the landscape law in 2007. Credit: Okayama City.

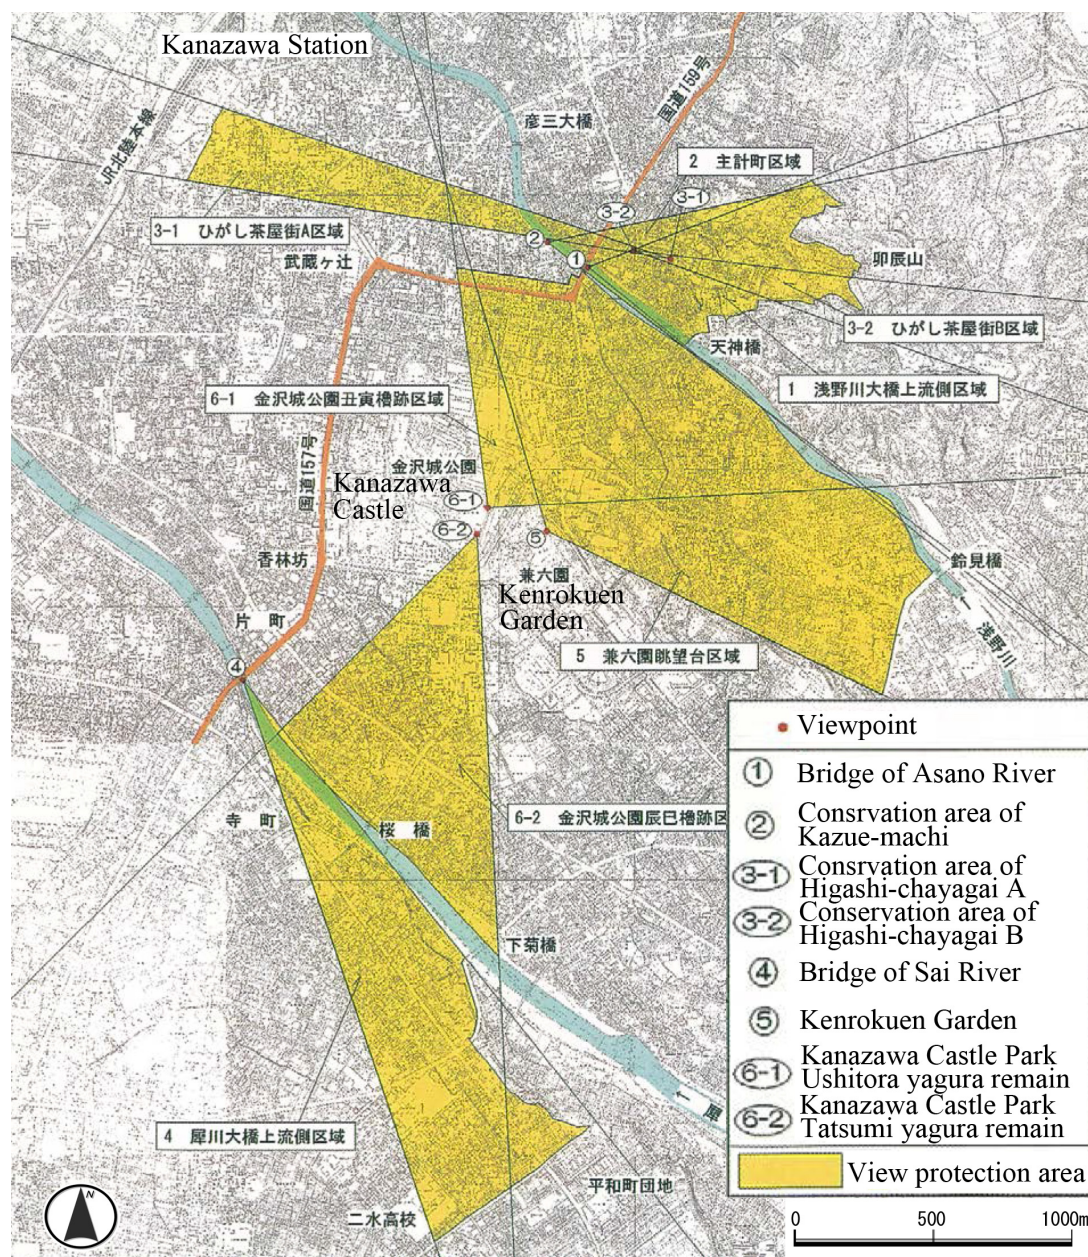
Figure 5 – Eight view protection areas published by the City's ordinance in 2003 and designated in the landscape plan of Kanazawa City by the landscape law in 2009. Credit: Kanazawa City.

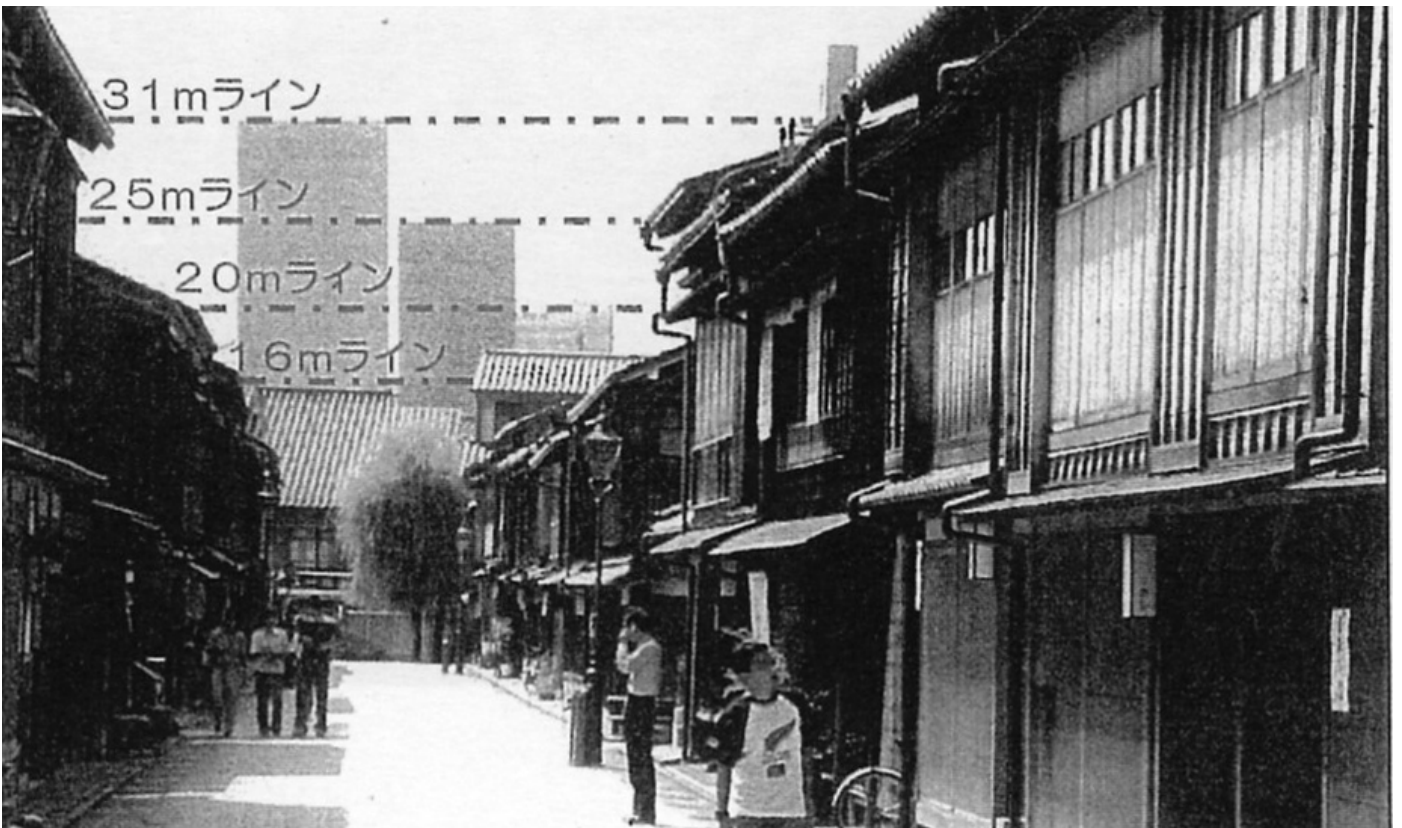
Figure 7 – The simulation of the visual impact of high-rise buildings (from 16 m to 31 m in height) from the viewpoint of 3-1. Credit: Kanazawa City.

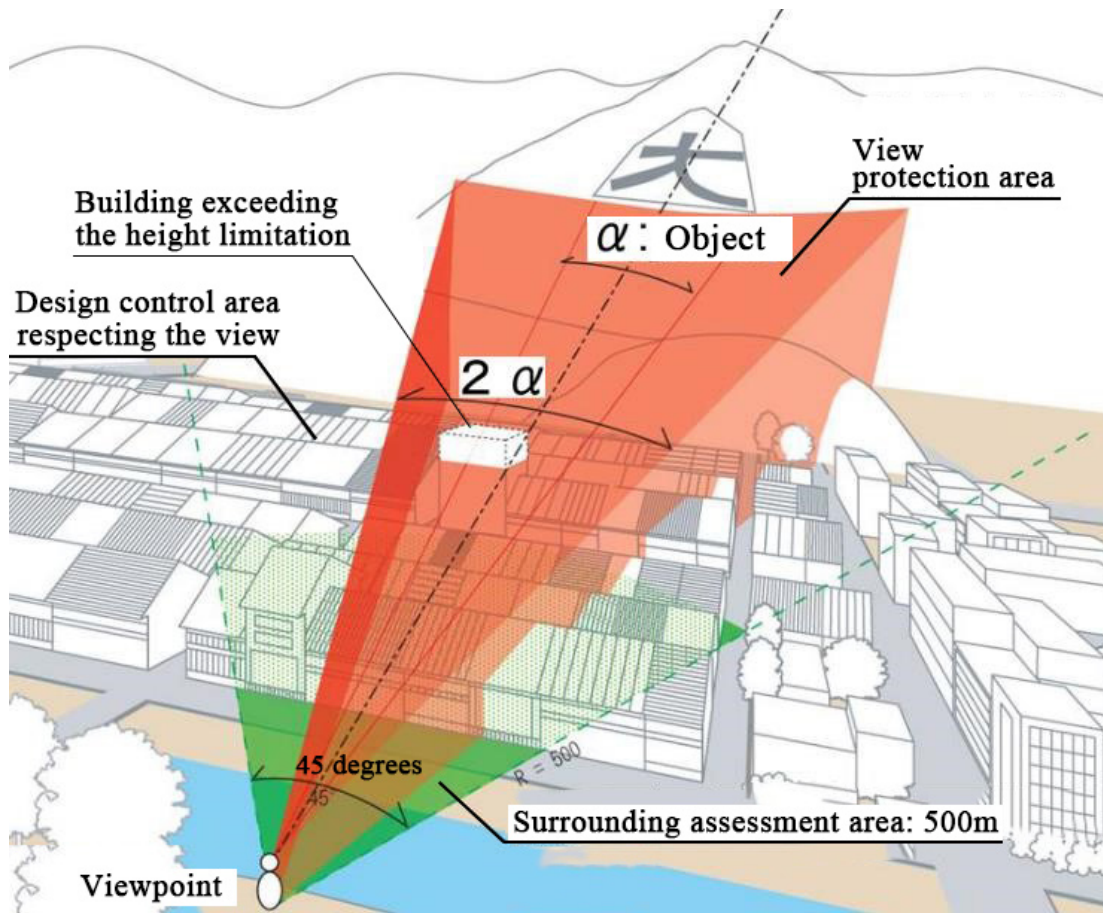
Figure 9 – Three types of control areas are designated in the landscape plan of Kyoto by the landscape law (2007). The first is the view protection area (in red), the second is the surrounding assessment area (in green, max. 500 m distance), and the third is the design control area respecting the view (max. 3 km distance). The widths of the view protection areas are designated by twice the width of the object of historic characters. Credit: Kyoto City.

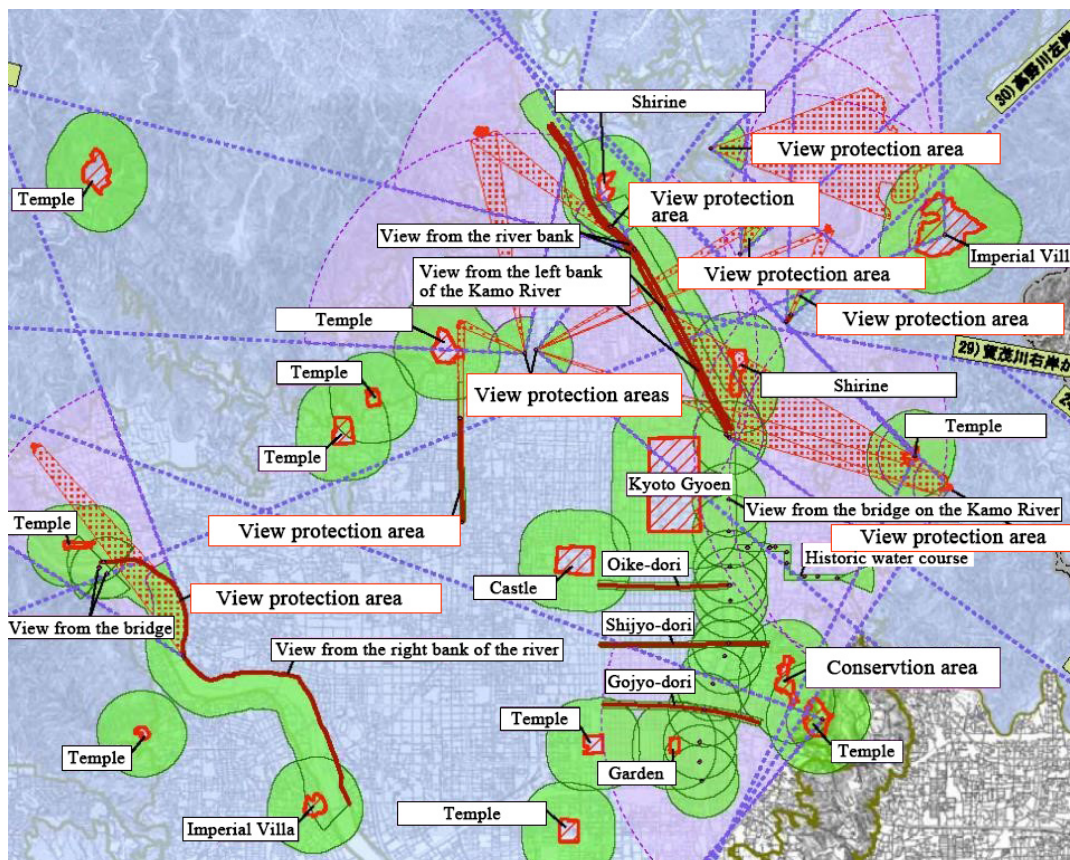
Figure 10 – A central part of the view protection map of the landscape plan of Kyoto (2007). View protection areas (in red dots), the surrounding assessment areas (in green), and the design control areas respecting the view (in violet), cover all the important monuments and views. Credit: Kyoto City.

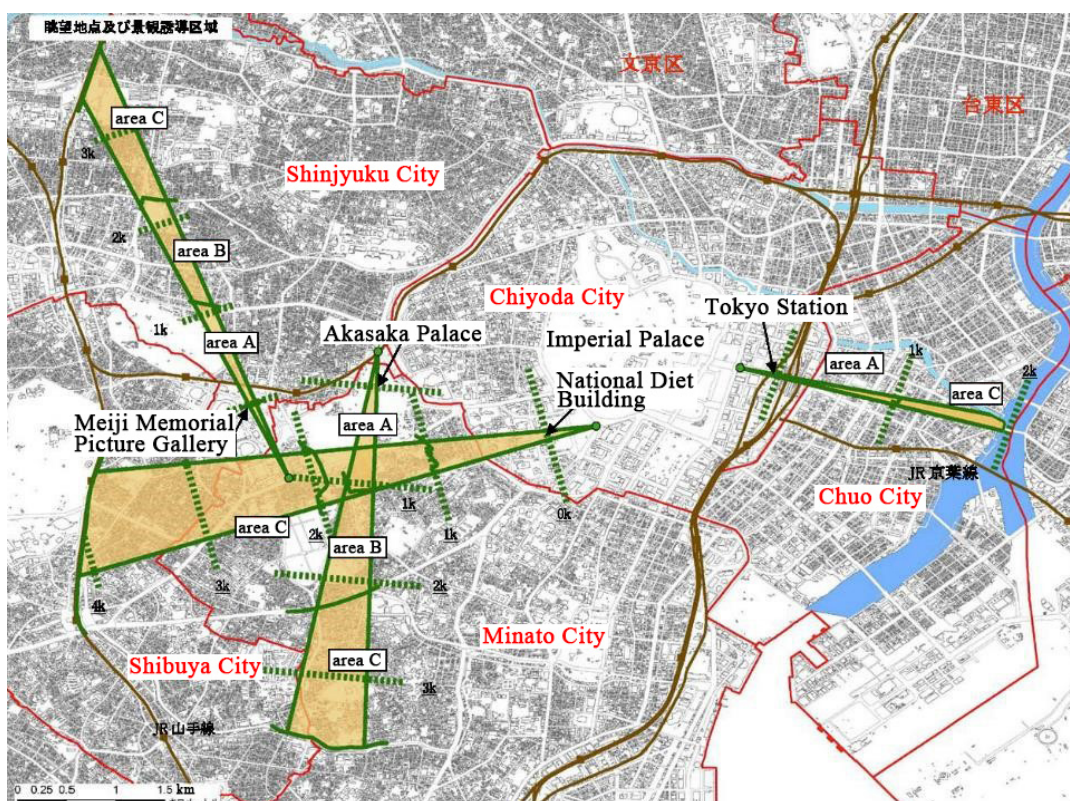
Figure 11 – Four view protection areas (in yellow) in the landscape plan of Tokyo (2007). All viewpoints are on the streets. The effect of the view protection appear behind historic buildings in the case of many skyscrapers in Tokyo. Credit: Tokyo metropolitan government.

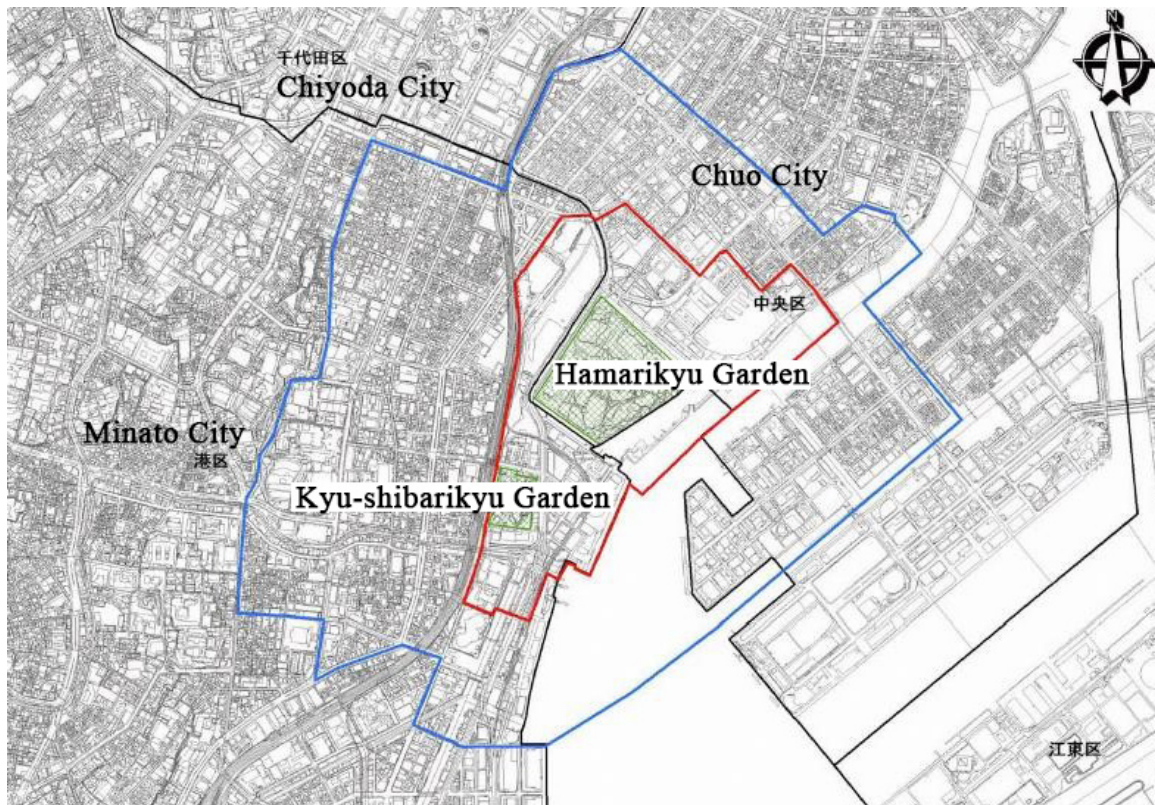
Figure 13 – An example of the surrounding assessment areas of ‘Hamarikyu Garden’ and ‘Kyu-shibarikyu Garden’ in the landscape plan of Tokyo (2007). There are two types of surrounding assessment areas. The red line signifies the design and advertisement control area that is lined at a distance of 300 m from the gardens. The blue line signifies the limit of the visual assessment area with a computer simulator. In these areas, viewpoints are designated in the gardens. Credit: Tokyo metropolitan government.

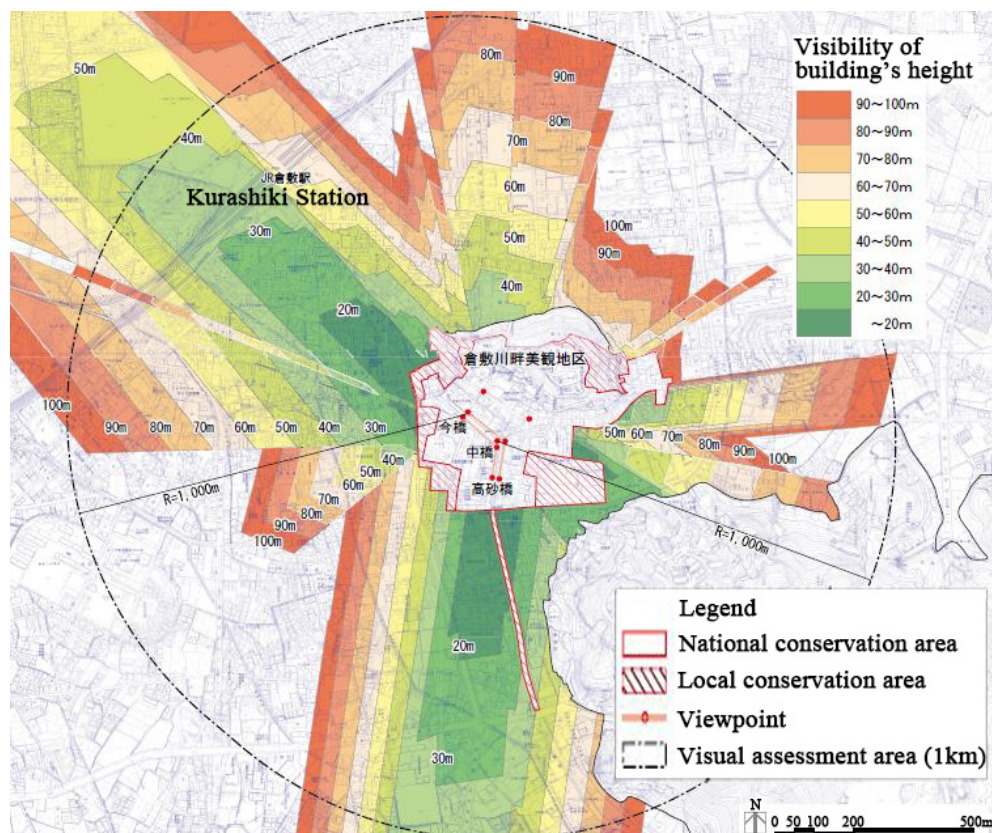
Figure 14 – Visibility check map of Kurashiki City (2014). Credit: Kurashiki City.

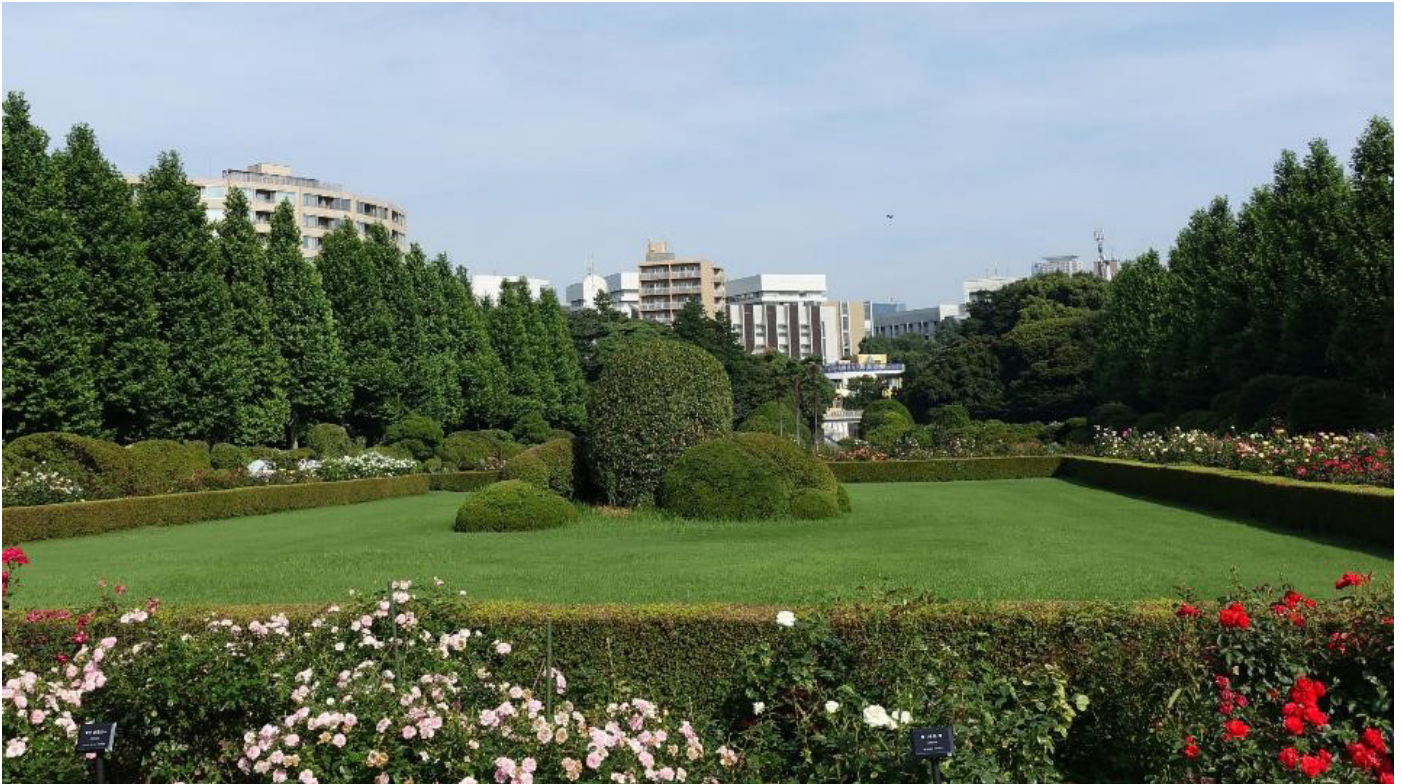
Figure 16 – The park landscape seen after the landscape plan (same location as Fig.15, 2016). The difference lies in the removal of the car parking tower advertisement in front of the historic French style garden. Credits: Masaru Miyawaki.

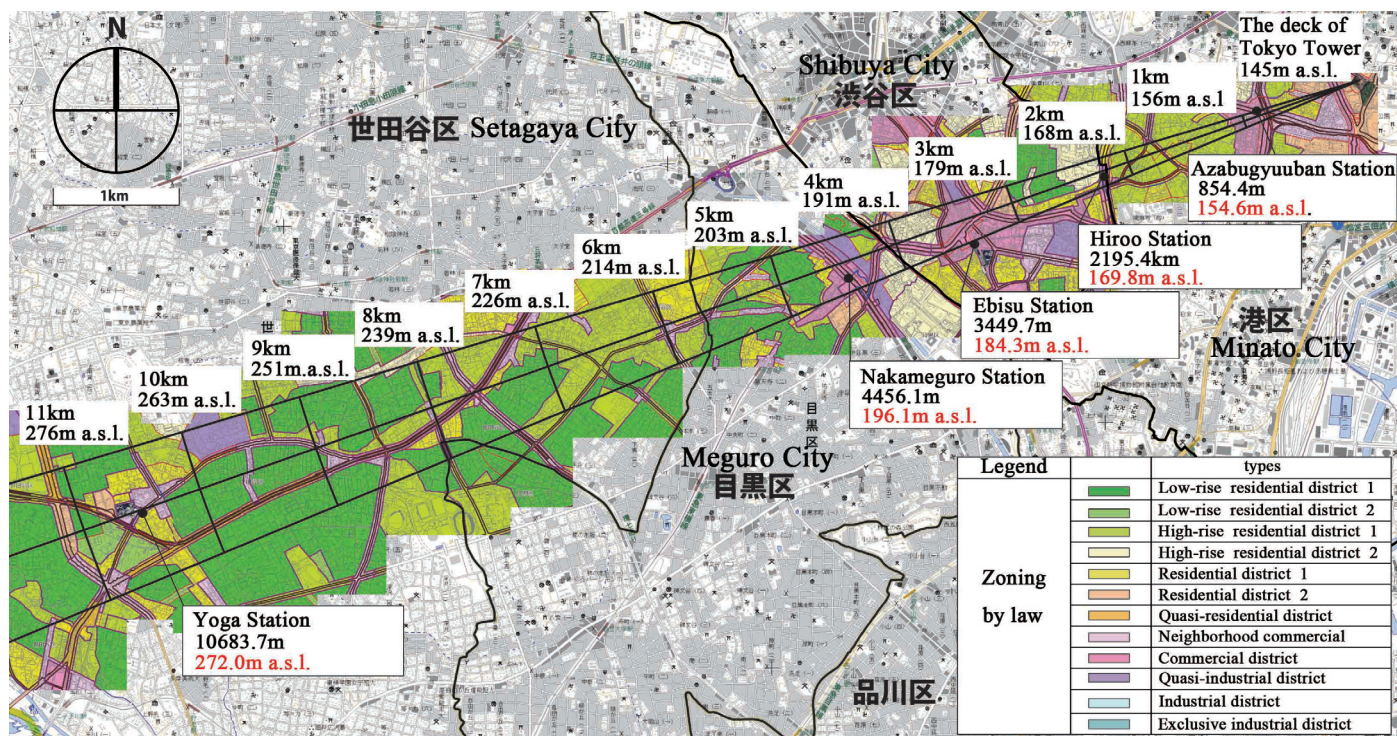
Figure 17 – A proposal of the view protection area from the deck of Tokyo Tower to Mt. Fuji. This map shows the maximum height of the buildings, respecting the view according to the distance from the viewpoint. The width of the view corresponds to the proposed width of the object (4b) in Fig.19. Credit: Masaru Miyawaki.

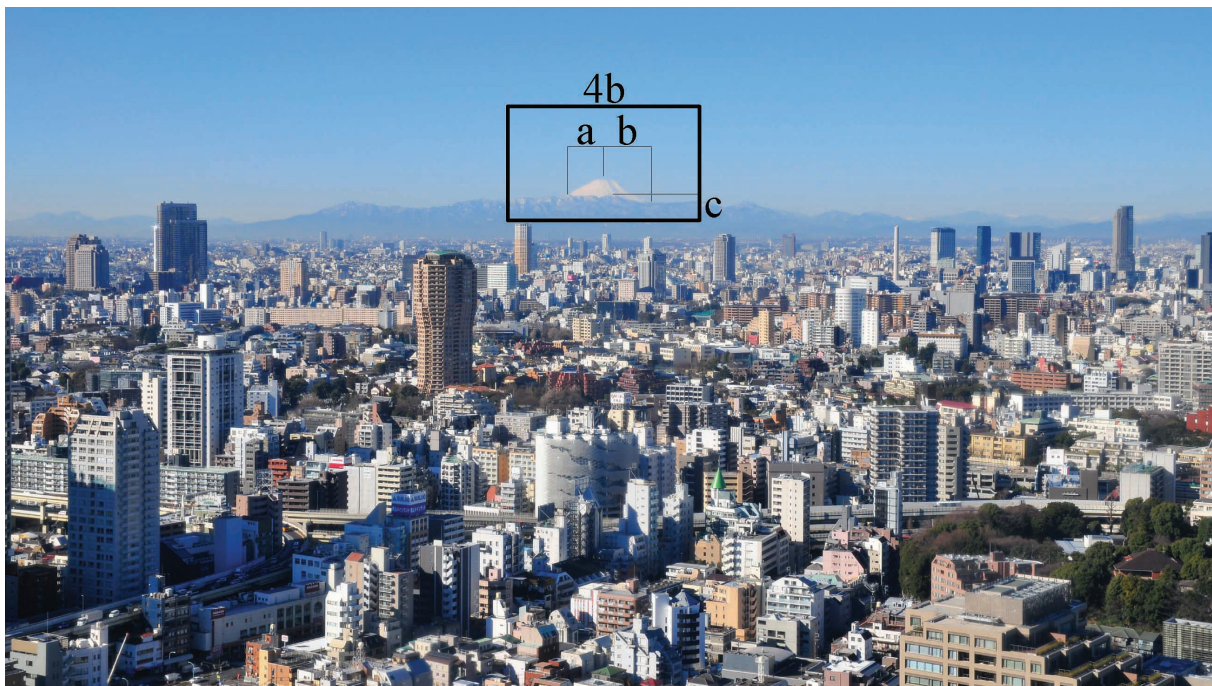
Figure 19 – A recent photo of Mt. Fuji from the deck of Tokyo Tower (Jan. 2013, 52.5mm lens; human eye view). Fig.18 and Fig.19 are situated at the same place. The Tokyo Tower (registered building) was built in 1958. The proposed view width of frame 4b (four times of width b) in the photo corresponds to the width of the view protection area in Figure 17. Credit: Masaru Miyawaki.

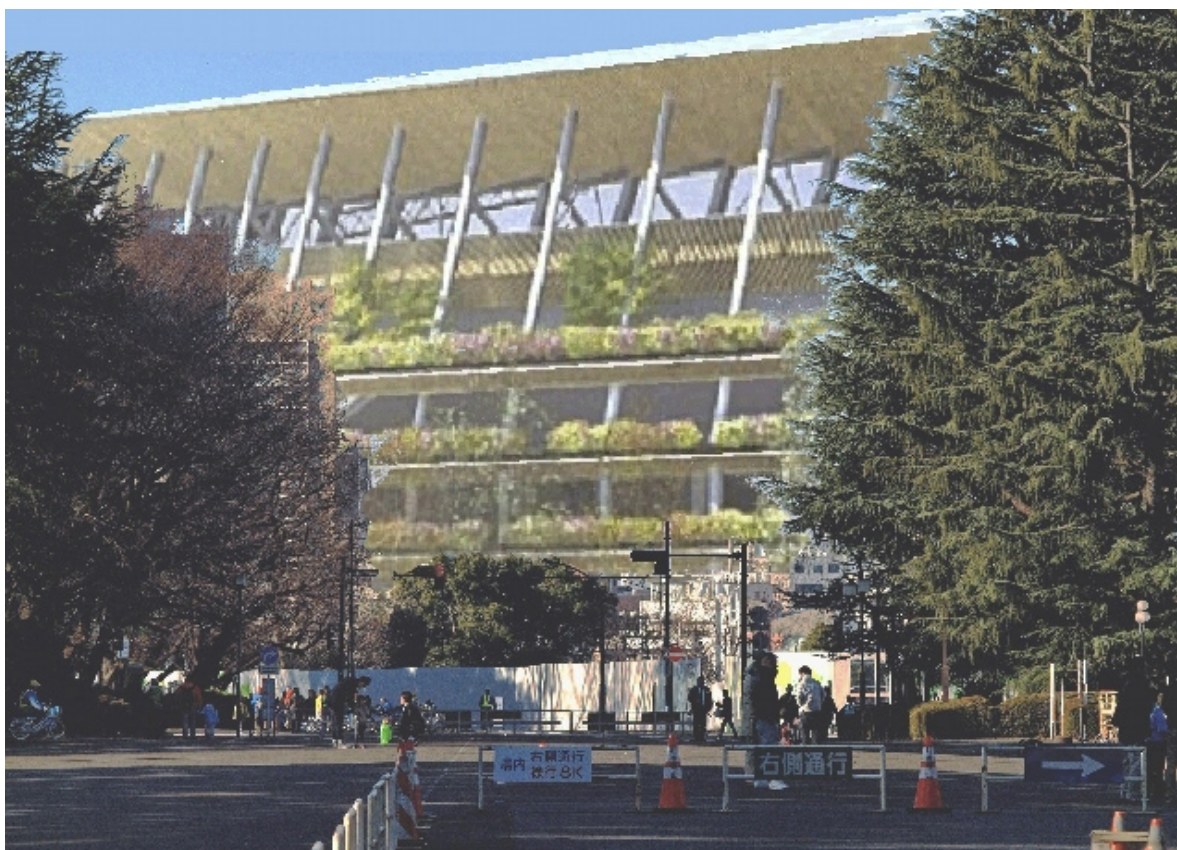
Figure 21 – Visual impact simulation from the same viewpoint of Figure 20. The view to Mt. Fuji is blocked by the new stadium from the park side. However, the stadium is designed to include a green facade and public space of the panoramic corridor on the higher level. Credit: Research Group of the Vista of Fuji-mi-zaka (Fujimizaka Chobou Kenkyukai).
