# CSE

## City Safety Energy

ISSN 2283-8767 [www.csejournal.net](http://www.csejournal.net) - ISSUE 1 | January - December 2017 | Semiannual publication

# The Stava catastrophic failure of July 19, 1985 (Italy): technical-scientific data and socioeconomic aspects

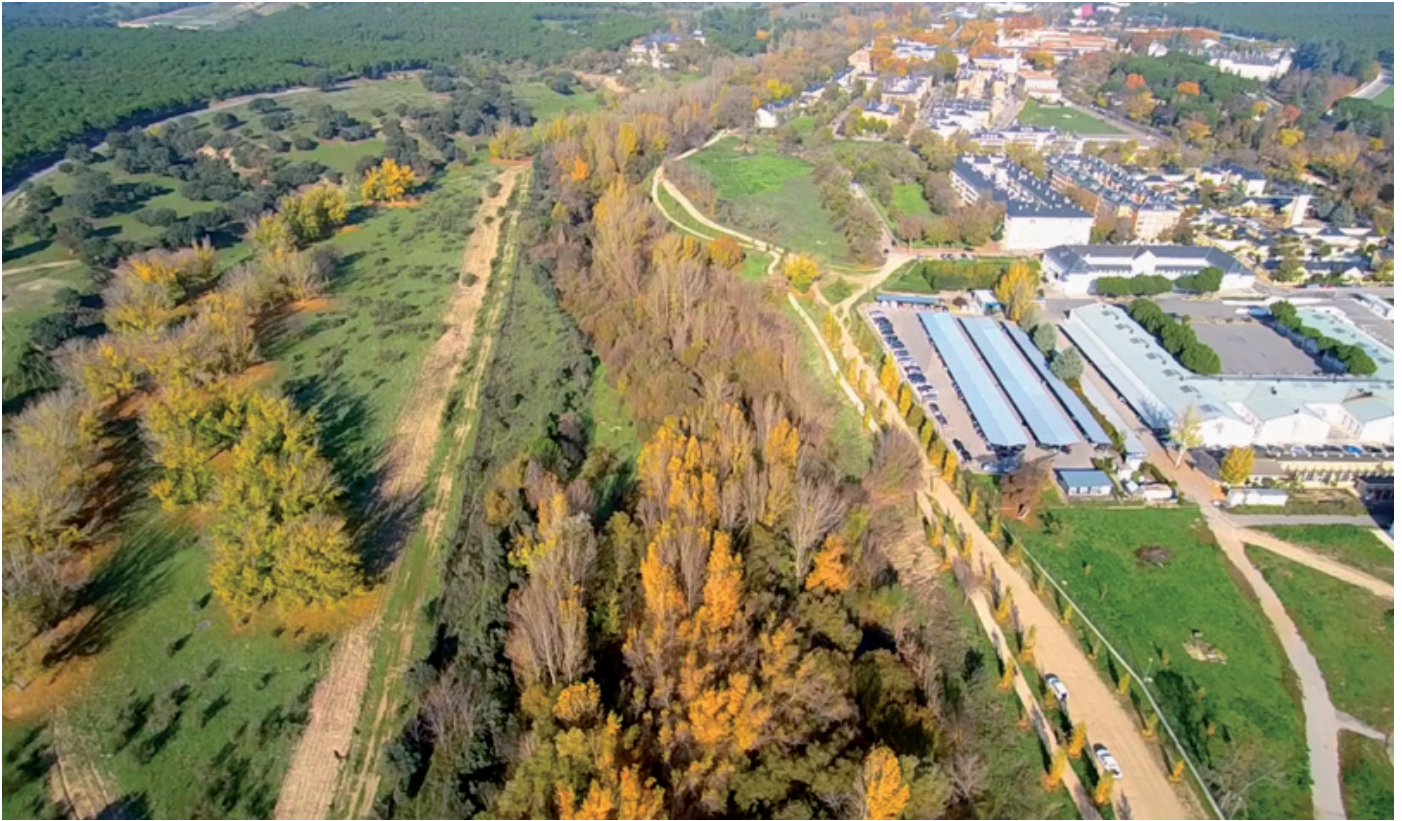
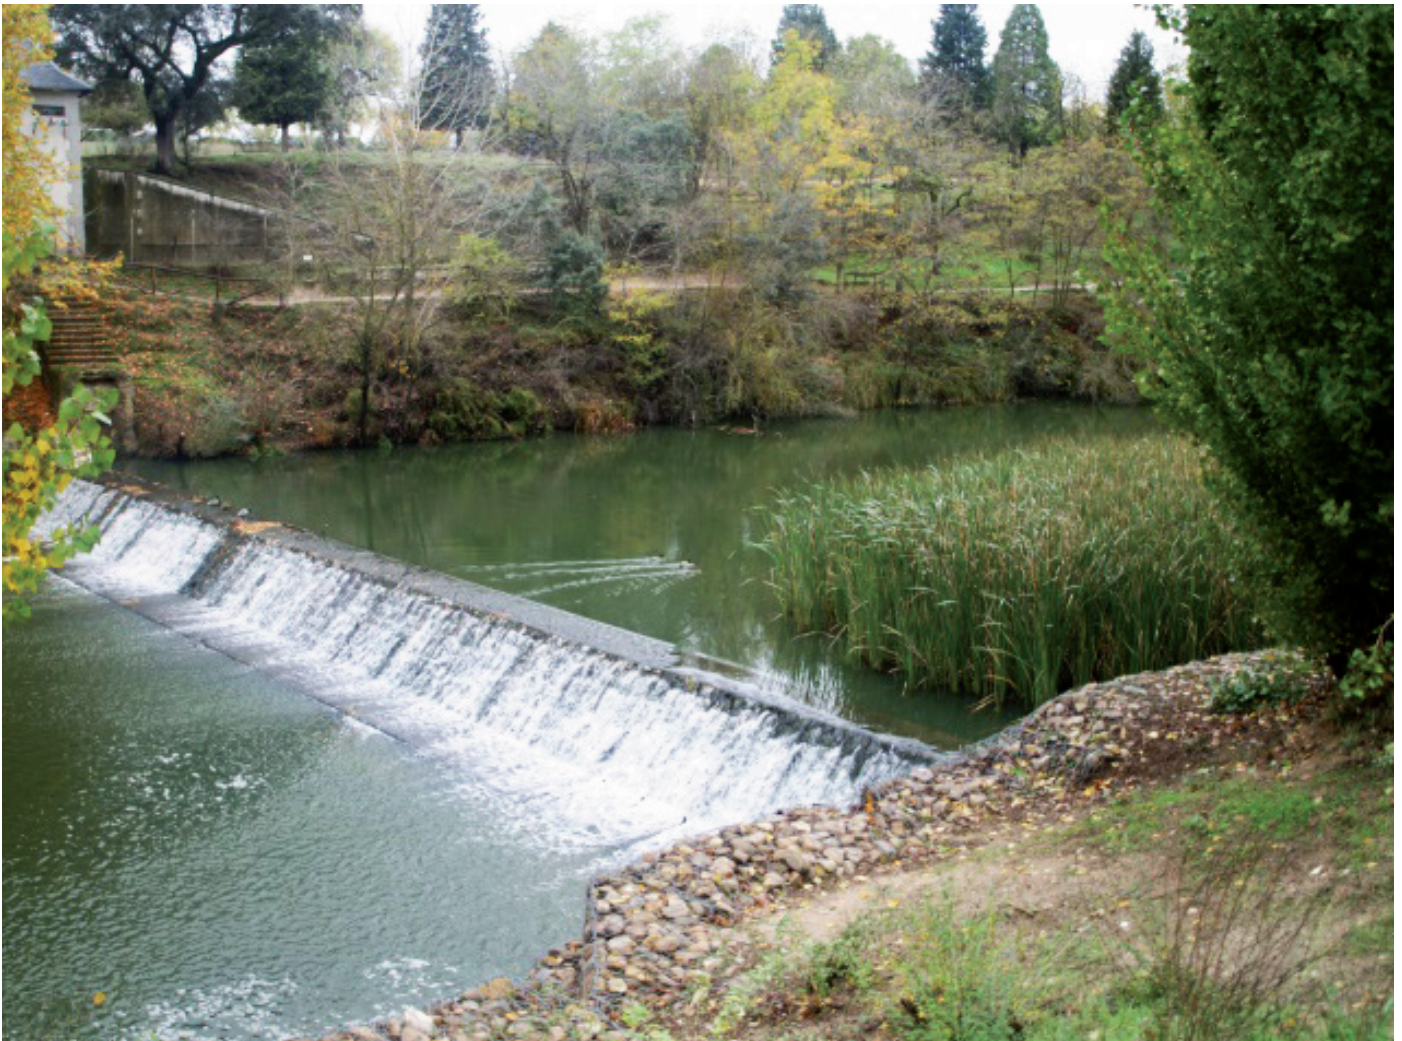
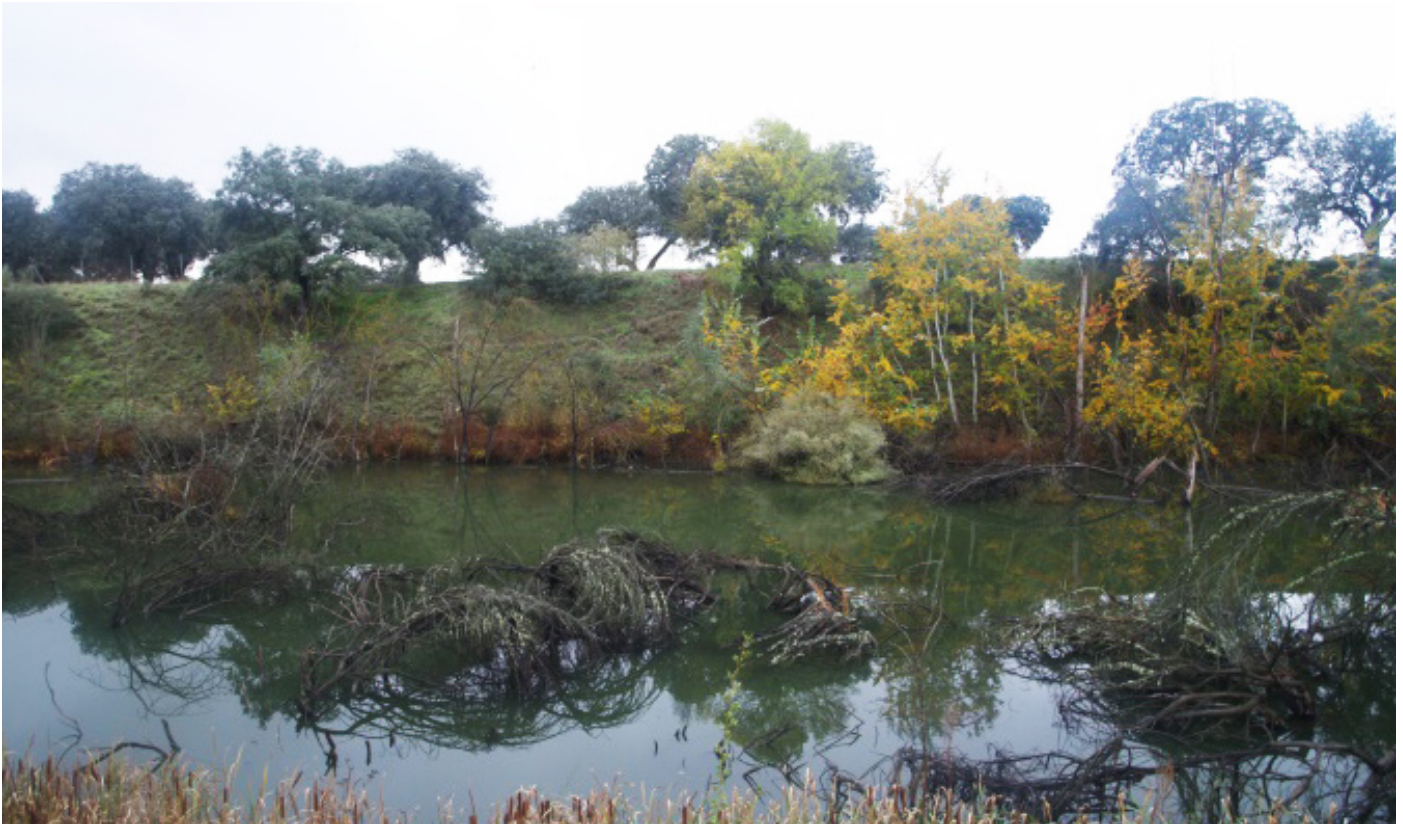
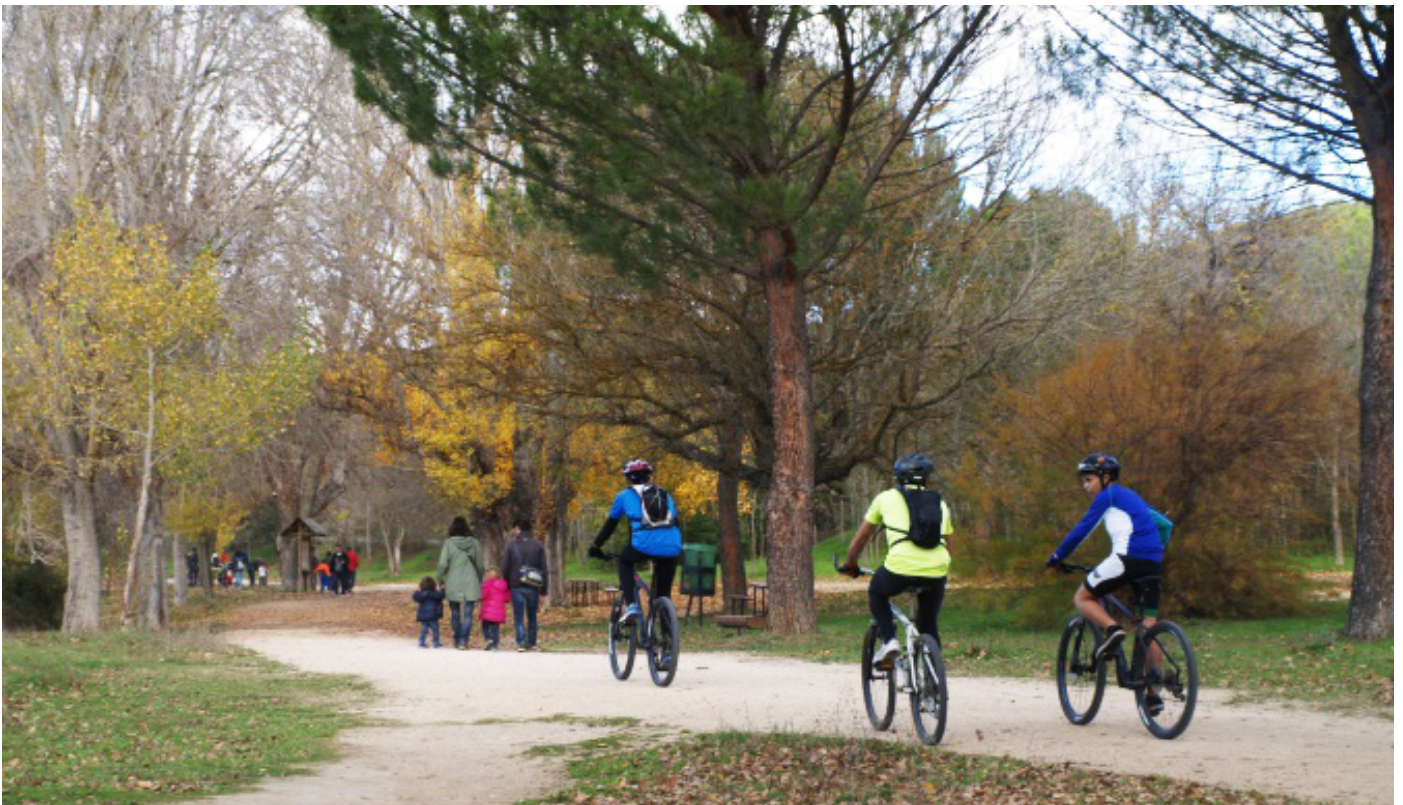
Figure 2 – Aerial and detailed views of some segments of the Manzanares River peri-urban reach which is presently being restored: (a) occupation of the former river left floodplain, which has contributed to the present narrow structure of the river system; (b) weir which creates an artificial backwater, where a fish ramp will be created; (c) artificial backwater which has motivated the death of the riparian stands; the dead trees have already been eliminated and the backwater will soon be reduced by allowing a better sediment transport; (d) massive public use along the reach, but disconnected from many river values; the paths will be improved and reconnected with the river banks, and cycle and pedestrian differentiated paths will be created.

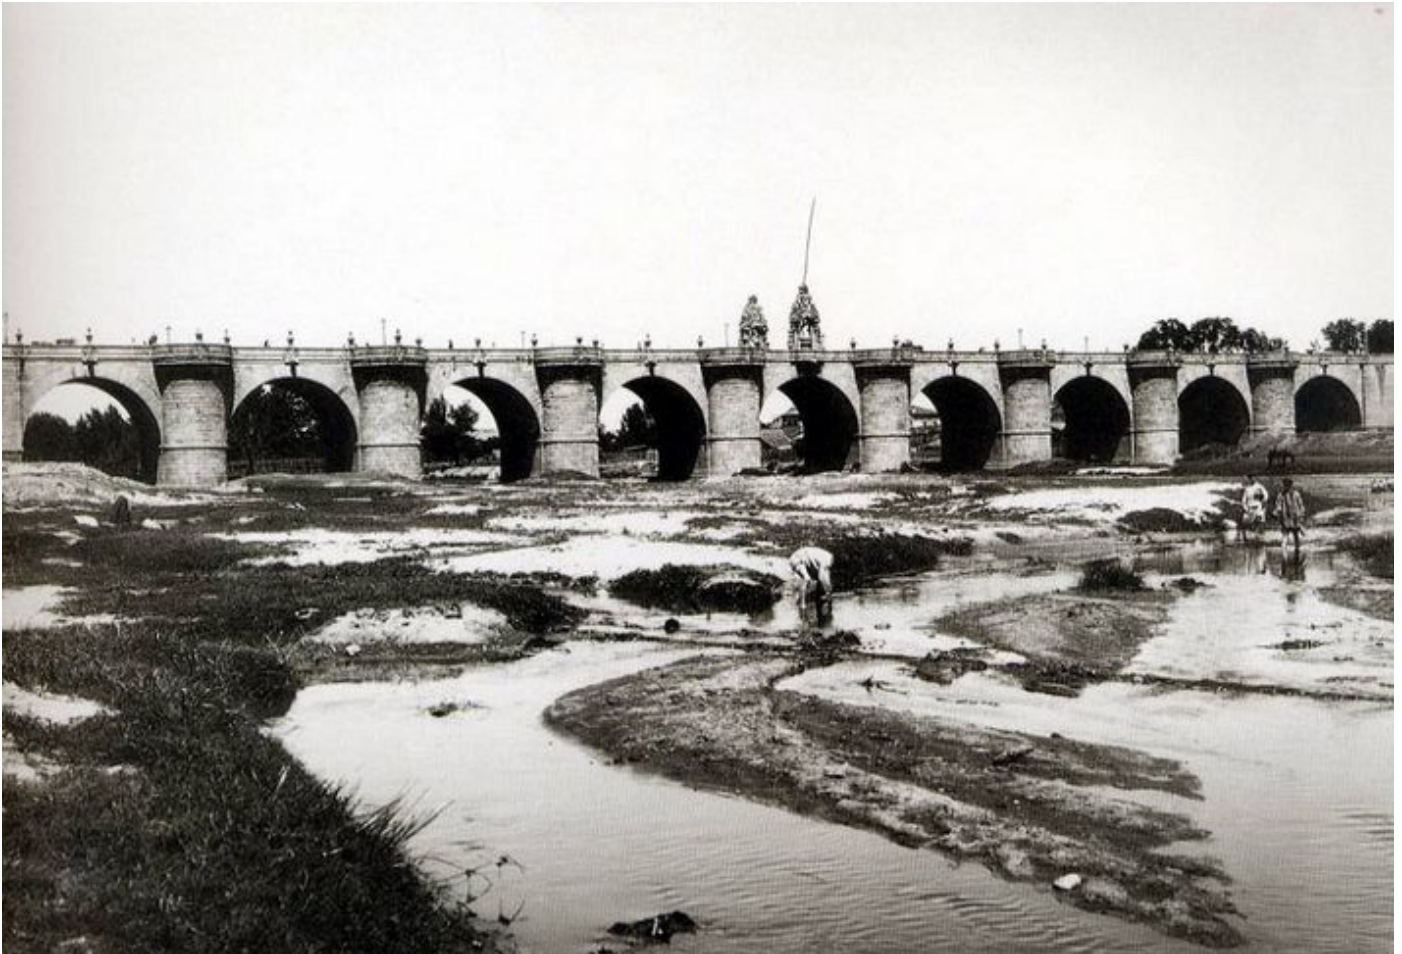
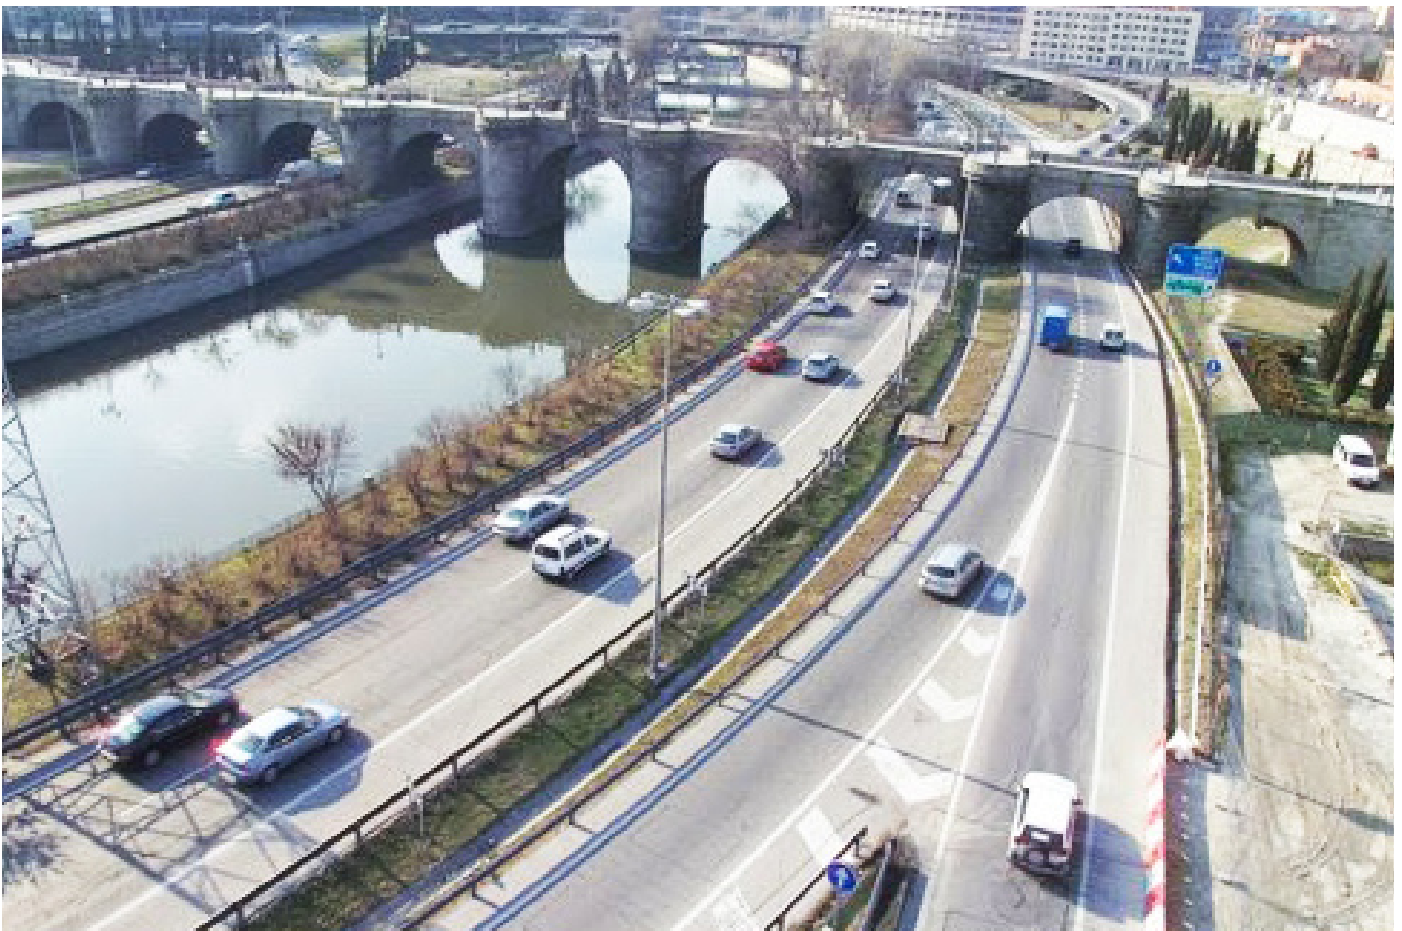
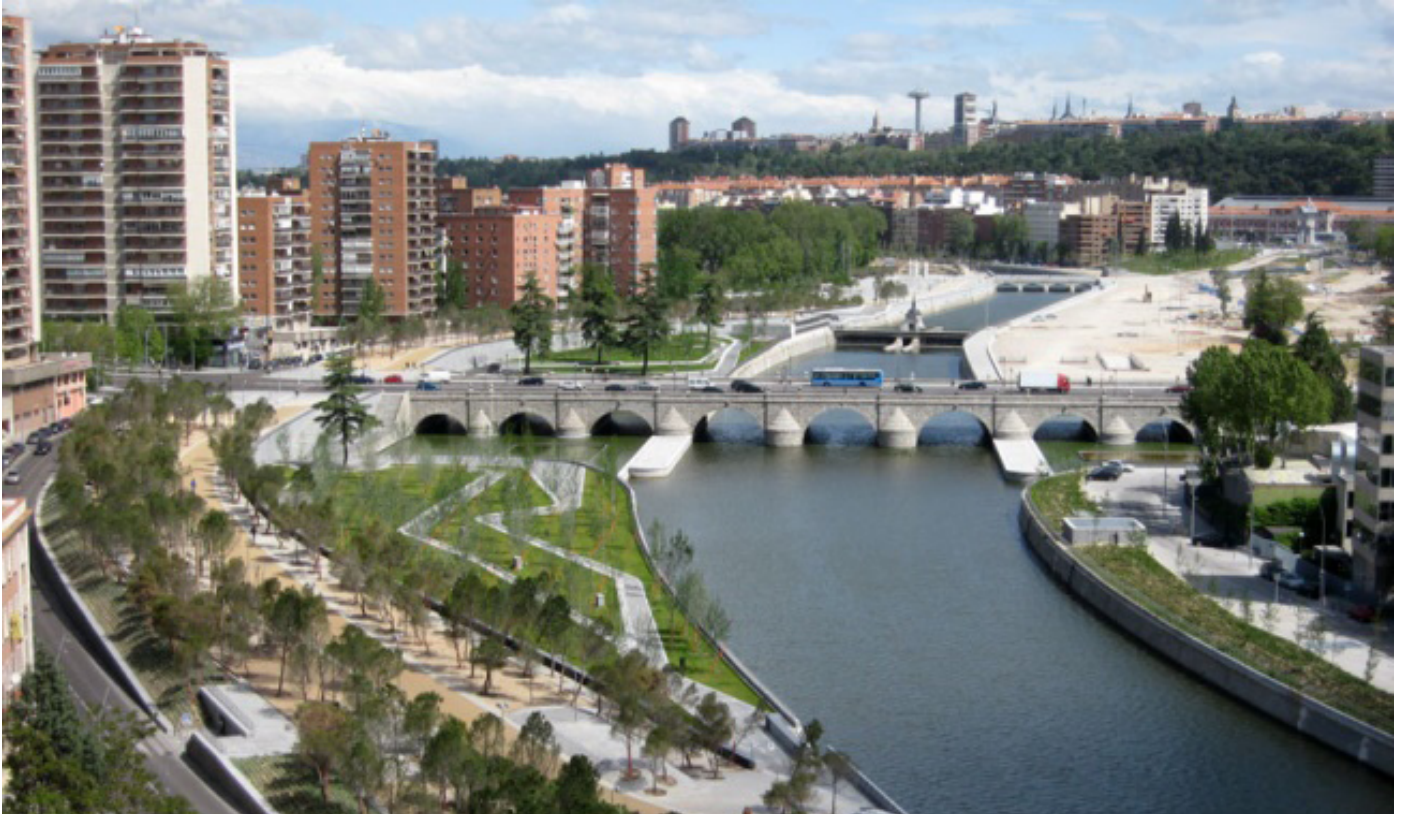
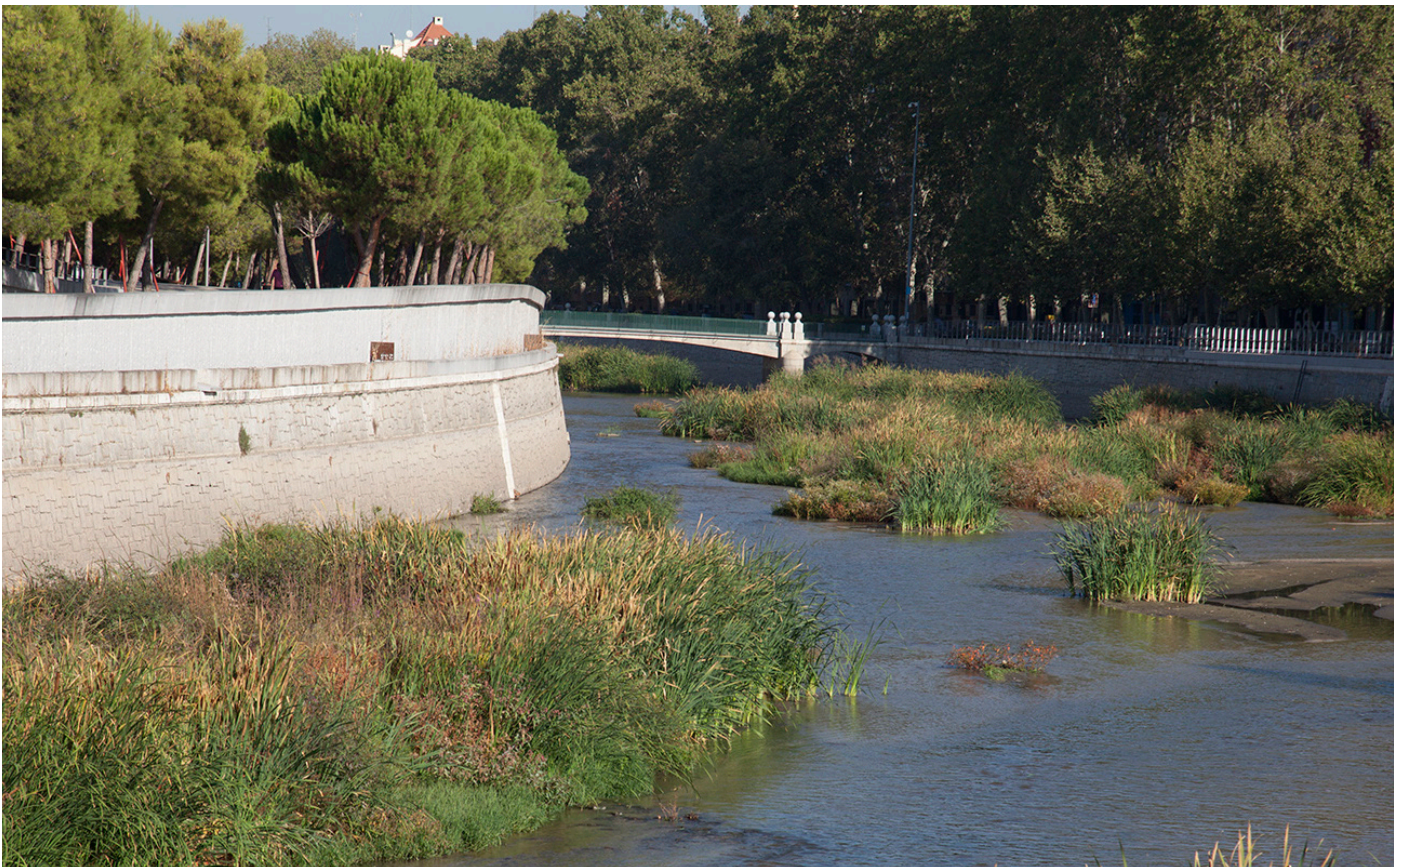
Figure 3 – Evolution of the urban reach of the Manzanares River near the historical Toledo Bridge: (a) by the early 20th century, showing the characteristic patterns of the near-natural multi-thread river channel; (b) in the 80s, after the canalization of the river and the construction of motorways along its banks; (c) in the early 21th century, after the motorways burial and the construction of a huge river park, but still with the weirs closed along the rivercourse; (d) after the full opening of the weirs and the allowance of a seminatural dynamics inside the limited space of the river (Photo sources: Madrid City Council and CEDEX).

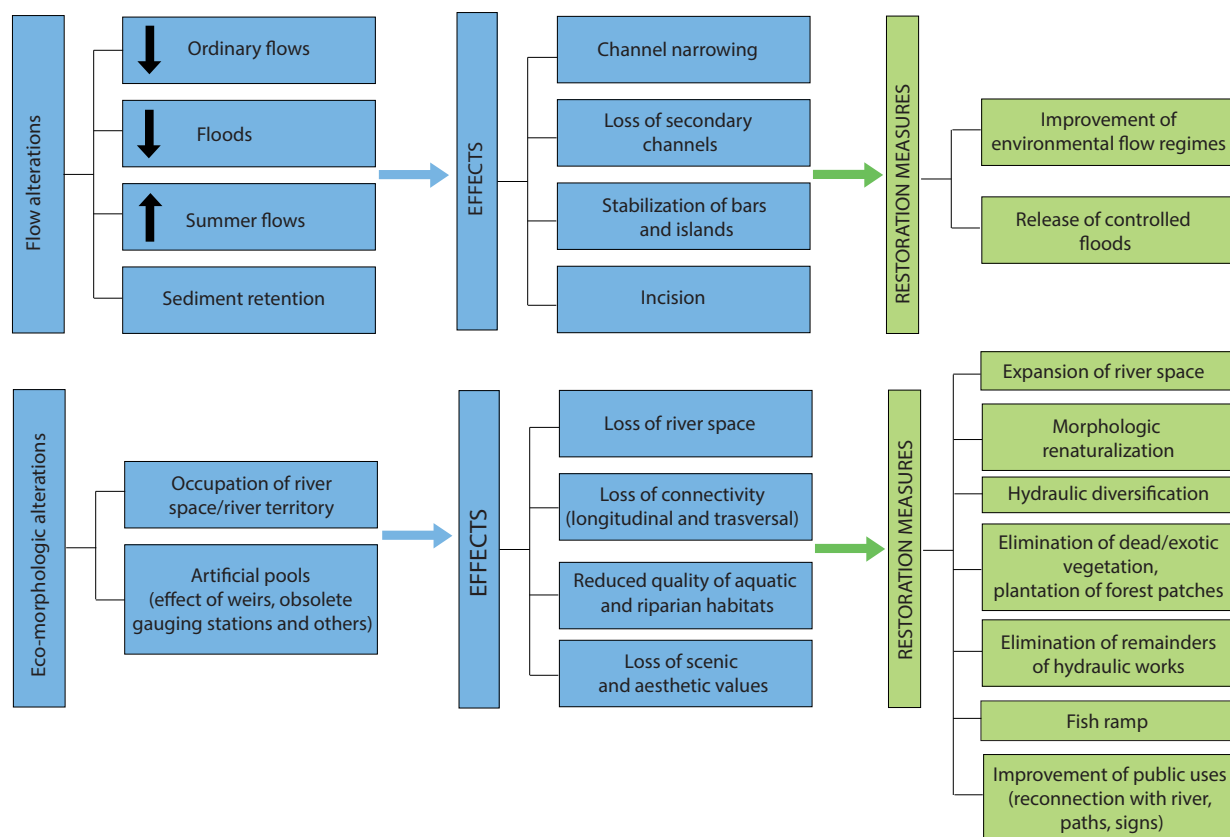
Figure 4 – Schematic diagram of the main flow and eco-geomorphic alterations which the Manzanares River peri-urban reach suffers today, their effects along the river, and the restoration measures under development (Source: J.A. Fernández Yuste, C. Martínez Santa-María, F. Magdaleno, pers. comm., 2015).

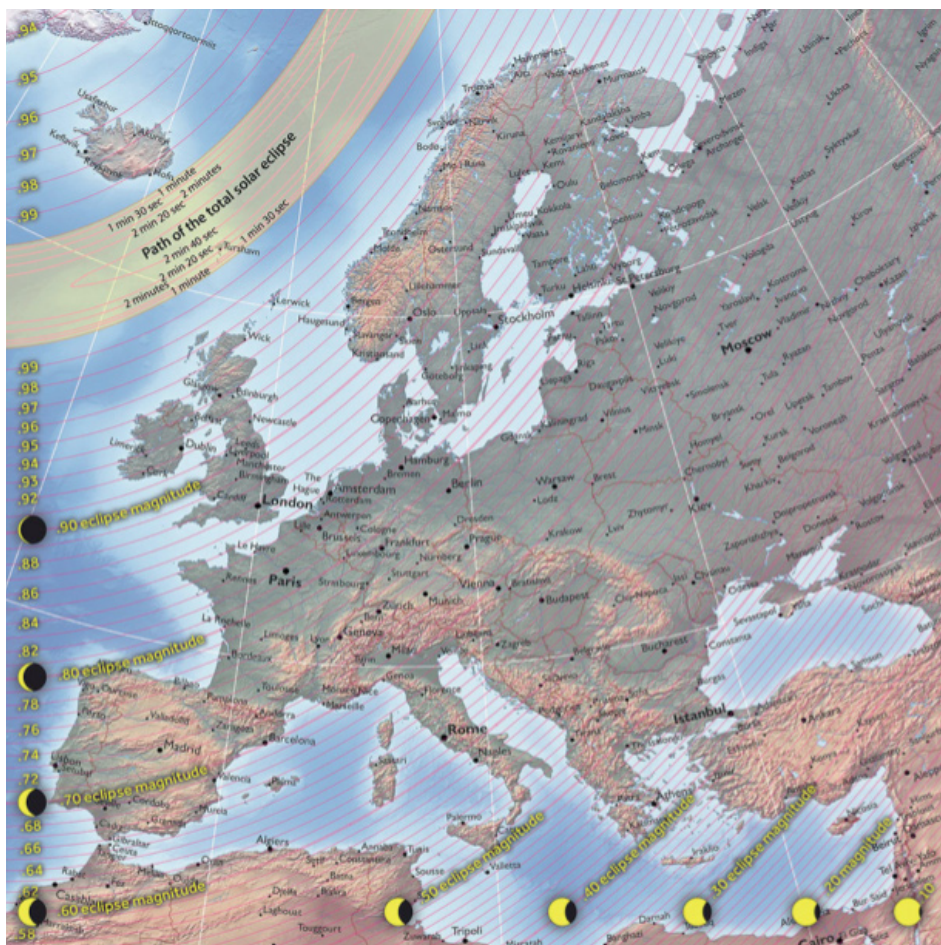
Figure 1 – Path of the solar eclipse of 20 March 2015, showing fractional obscuration of the Sun at maximum eclipse. Image courtesy of <http://www.greatamericaneclipse.com>; copyright Michael Zeiler and reproduced with permission

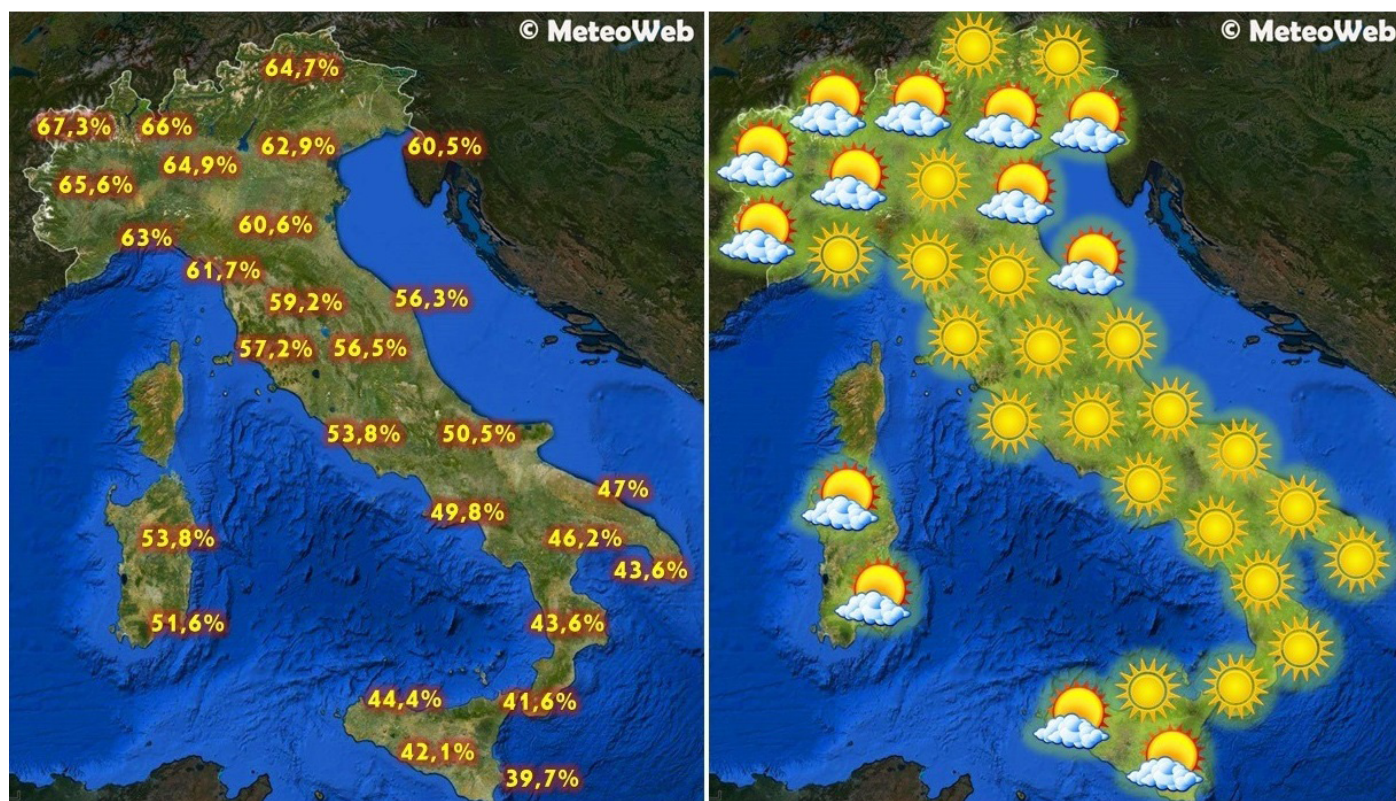
Figure 2 – Eclipse of 20 March 2015: percent of the Sun's dimming and meteorological conditions in Italy.

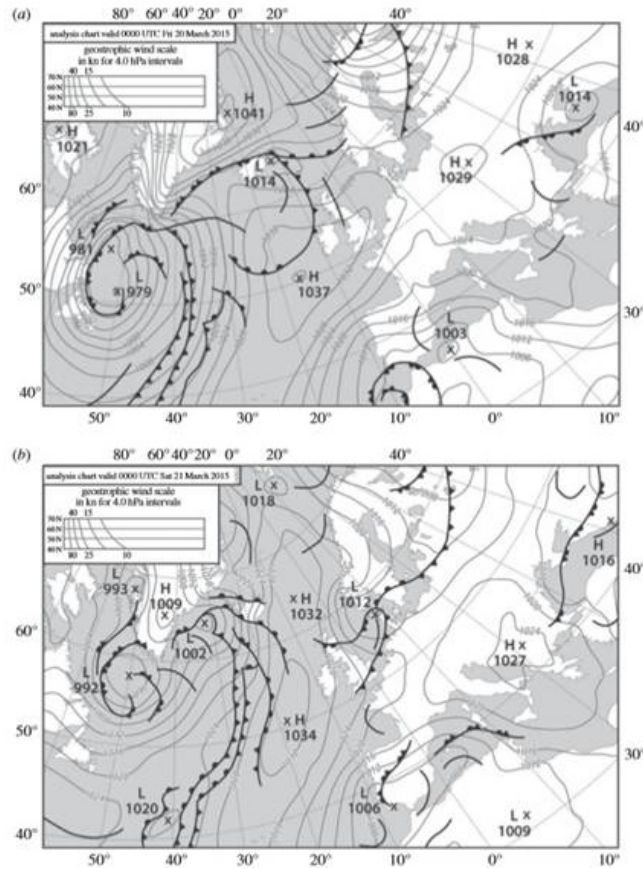
Figure 3 – Met Office mean sea-level pressure chart for (a) 00:00 UTC on 20 March 2015 and (b) 00:00 UTC on 21 March 2015 (redrawn). Original charts obtained from the Wetterzentrale Topkarten website (<http://www.wetterzentrale.de/>).

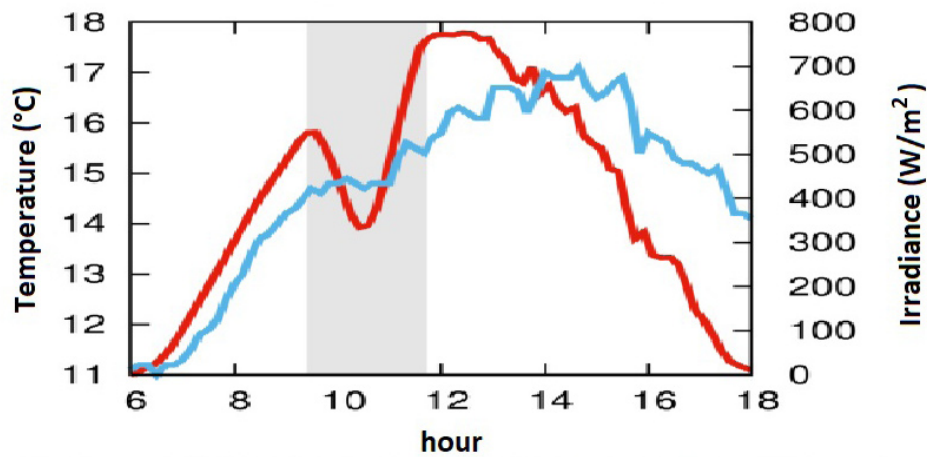
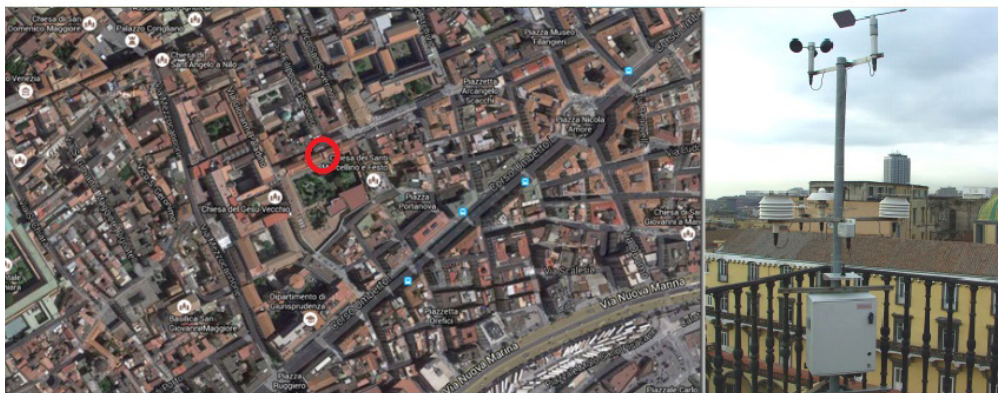
Figure 4 – (Top) Temperature and solar irradiance measured in the historical center of Naples. (Bottom) Photographs of the Meteorological Observatory of San Marcellino indicated by the red circle.

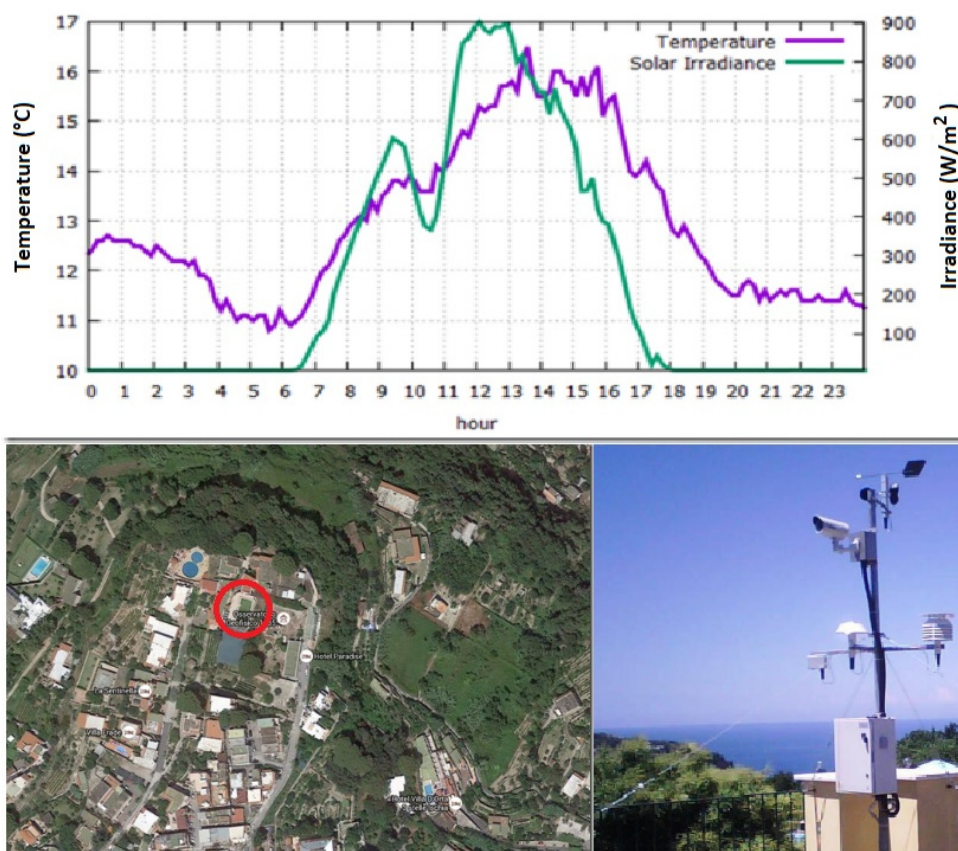
Figure 5 – (Top) Temperature and solar irradiance measured in Casamicciola. (Bottom) Photographs of the Geophysical Observatory in Casamicciola indicated by the red circle.

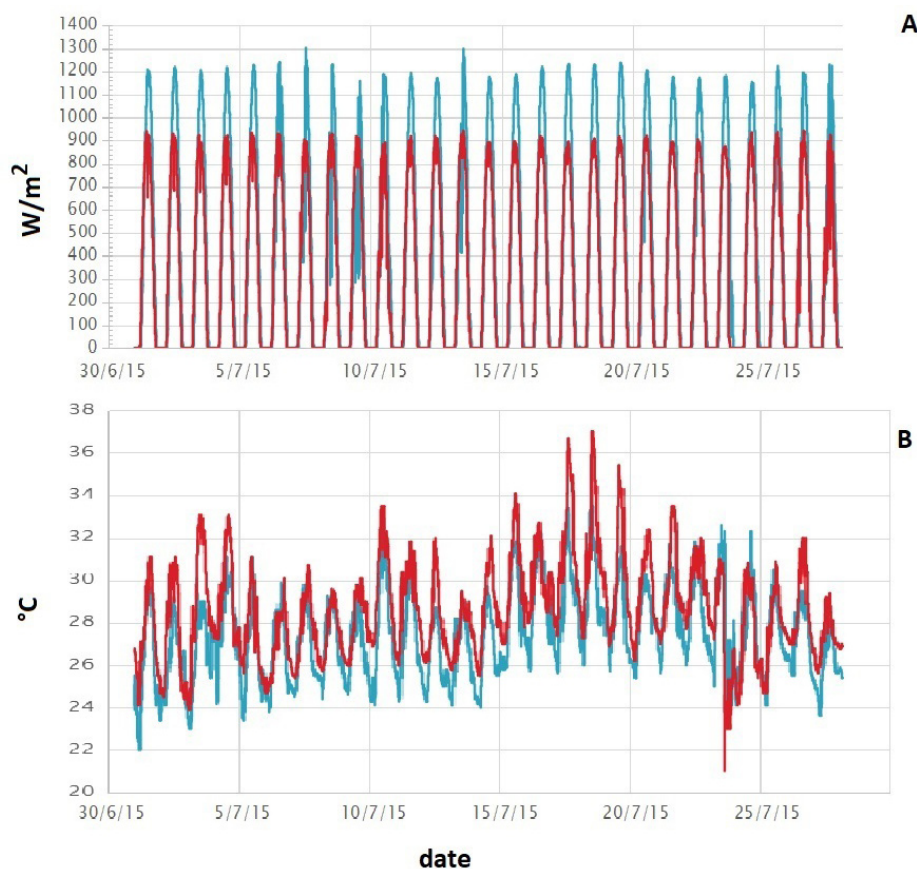
Figure 6 – (A) Solar irradiance measured in the meteorological observatory of San Marcellino Temperature (red) and in the geophysical observatory in Casamicciola (blue). (B) The air temperature measured in the two observatories, respectively.

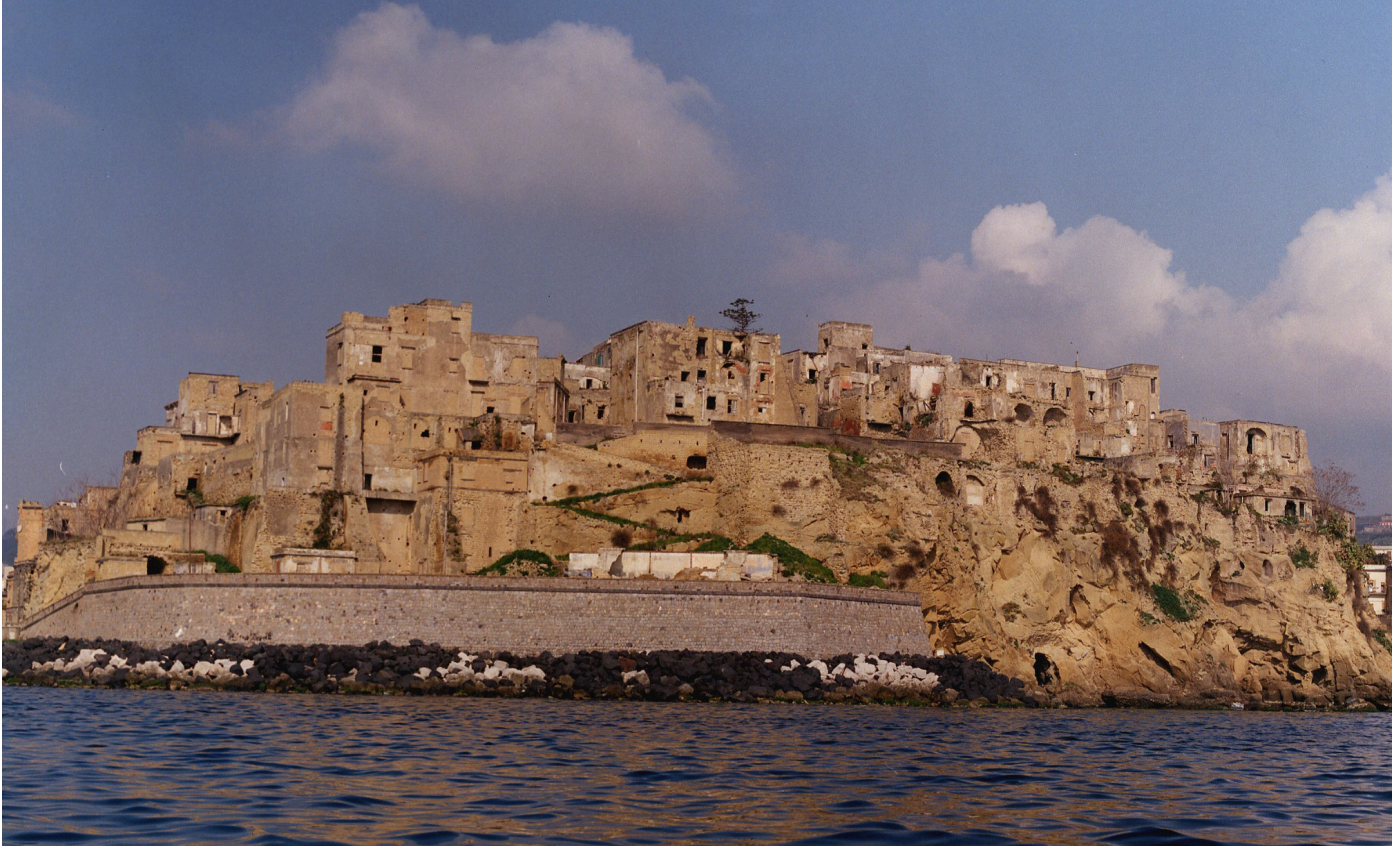
Figure 2 – Rione Terra in Pozzuoli, view from the sea.

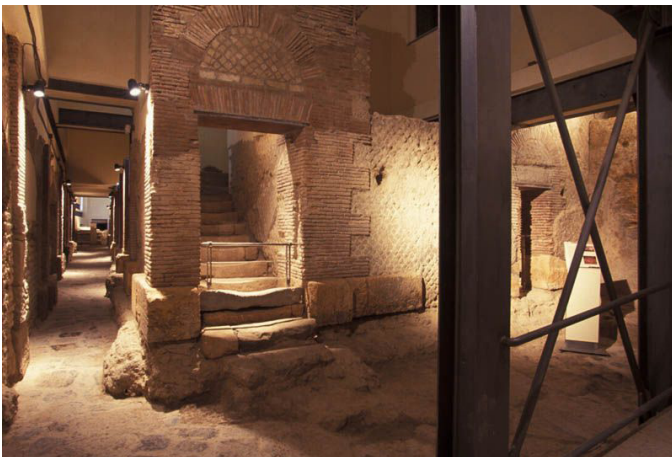
Figure 3 – Rione Terra, Roman Building, detail.

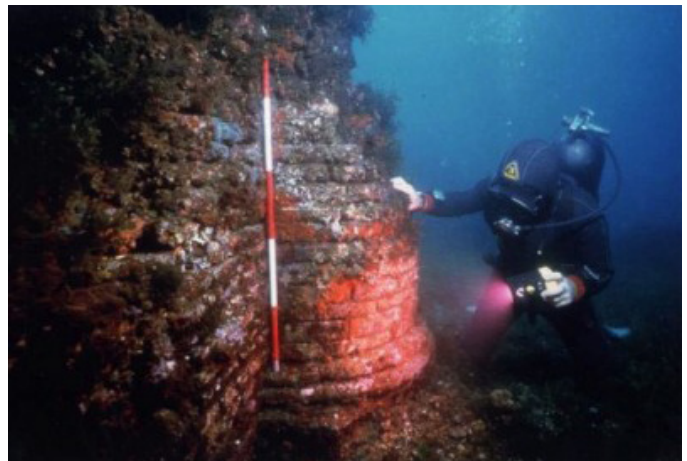
Figure 4 – Baia, Roman submerged building, detail (Photo by ASNA archiv).

The ancient *Baiae*, famous for its beauty and thermal water springs, was the holiday resort of the Roman aristocracy. The surrounding hills and the coastal coastline were occupied by luxurious villas whose owners are famous by literary sources. This area due to bradyseism has dramatically changed its coastal profile and some of these residential villas have been submerged (Figure 4).

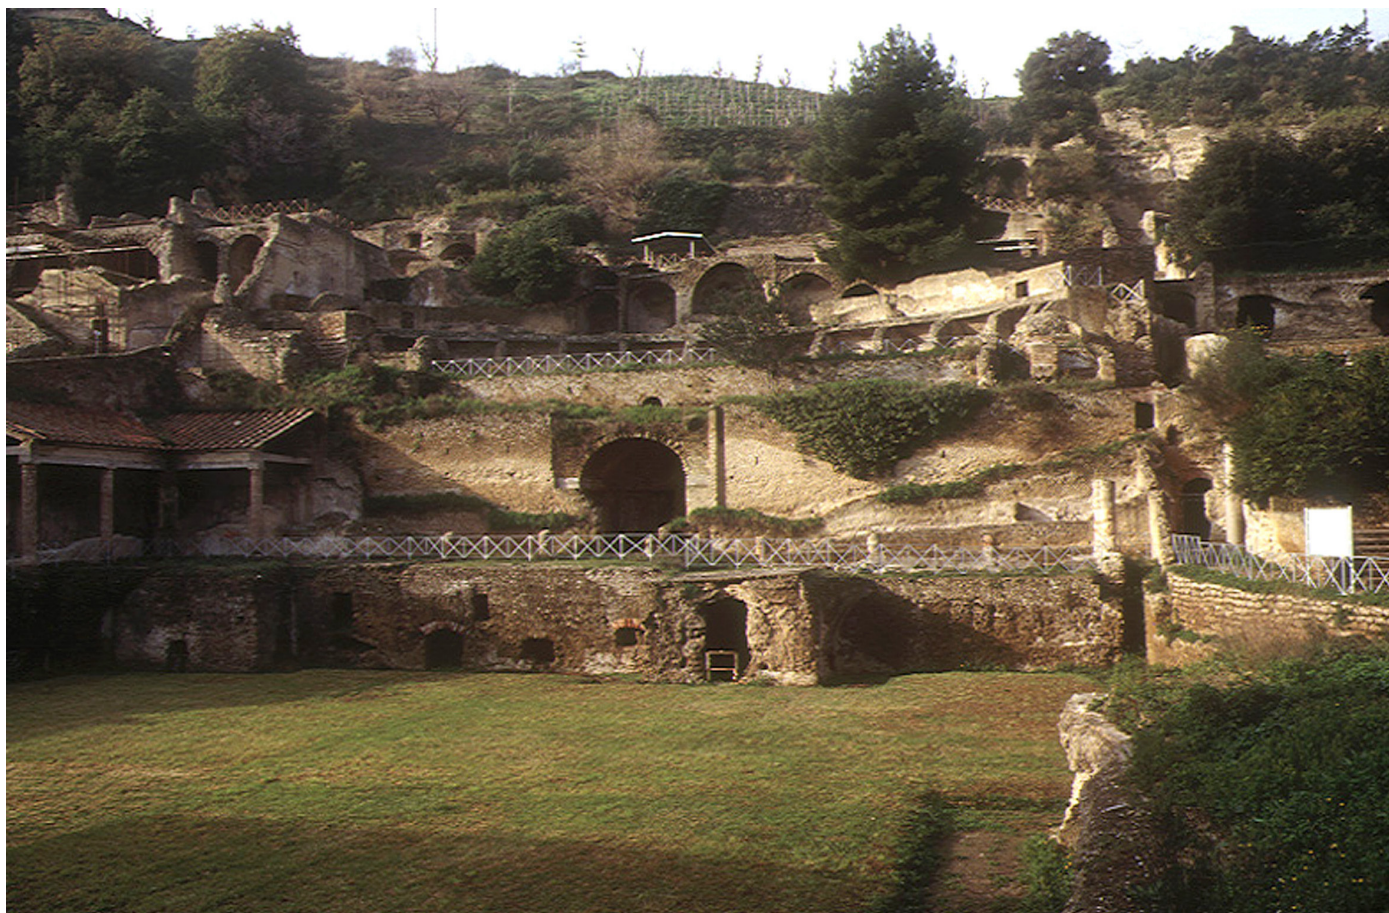
Figure 5 – Baia, Archaeological complex of "Terme di Baia" (Photo by ASNA archiv).

The so called archaeological complex "Terme di Baia" is an archaeological park extending along 40.000 sq.m. and it is divided in five sections: *Villa dell'Ambulatio*, *Mercurio* area, *Sosandra* area, *Piccole Terme* and *Venere* area that embrace patrician residences and a thermal complex (Figure 5).

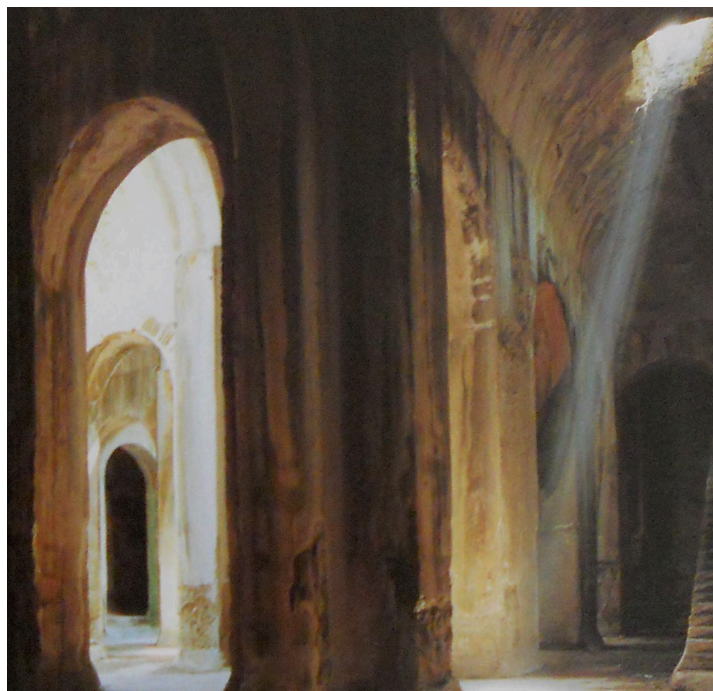
Figure 7 – Misenum, Piscina Mirabilis.

The walls were built in *opus reticulatum* with lanes of bricks in the middle and pillar of tuff block, they have a coat of *cocciopesto* with a curb at the base to prevent infiltrations (Figure 7).

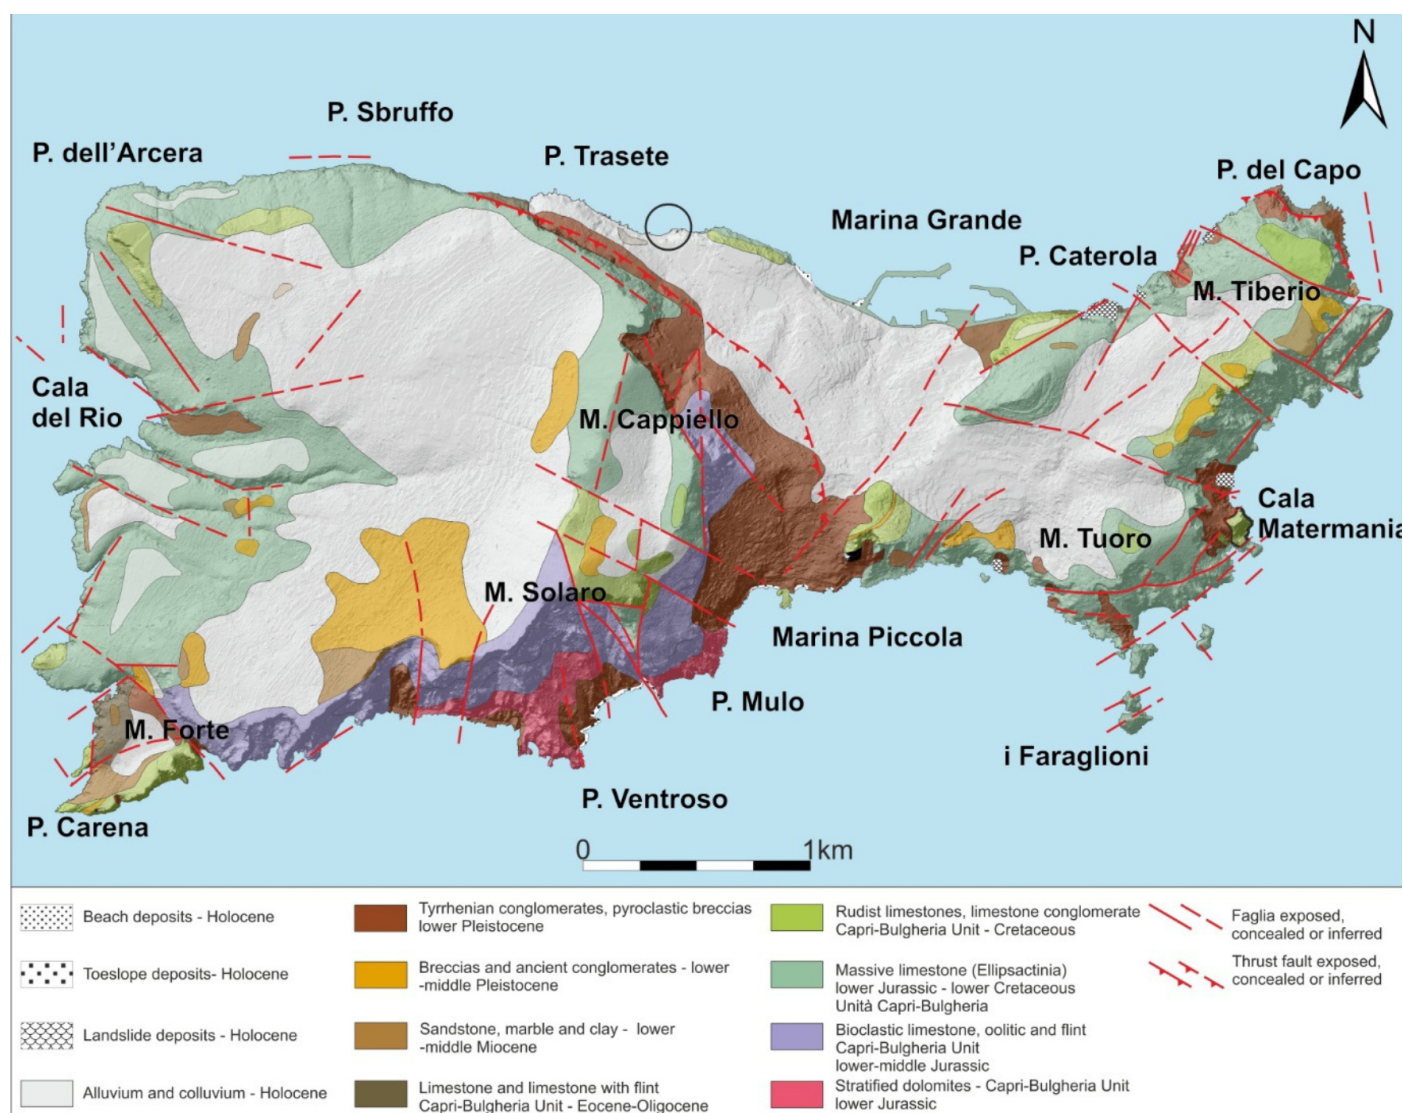
Figure1 – Schematic geological map of Capri Island (after Barattolo et al., 2016); open circle is the study area.

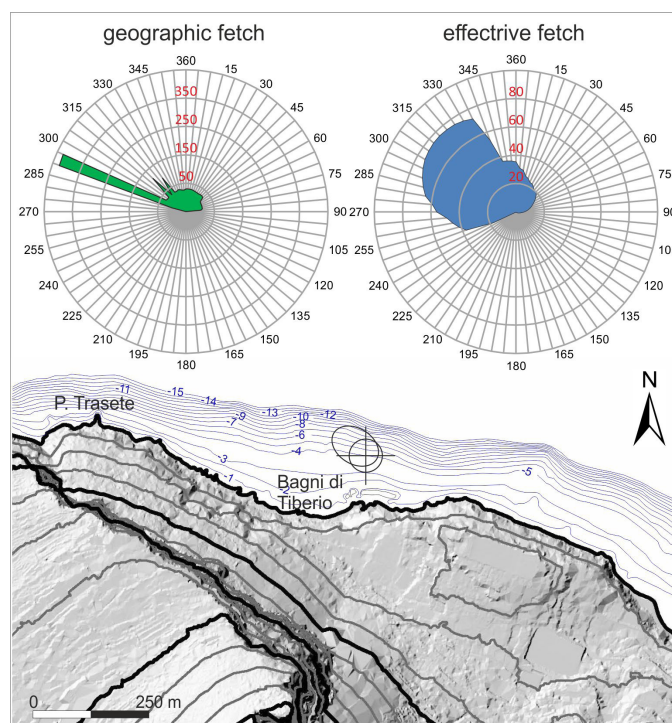
Figure 3 – Polar diagrams of geographic and effective fetches calculated in A, according to Milano (1977), considering extension of offshore, the study area; isobath (-m bsl) from Piano Stralcio di Bacino per la Difesa delle Coste – Autorità di Bacino Campania Centrale.
