# CSE

## City Safety Energy

ISSN 2283-8767 [www.csejournal.net](http://www.csejournal.net) - ISSUE 1 | January - December 2017 | Semiannual publication

# The Stava catastrophic failure of July 19, 1985 (Italy): technical-scientific data and socioeconomic aspects

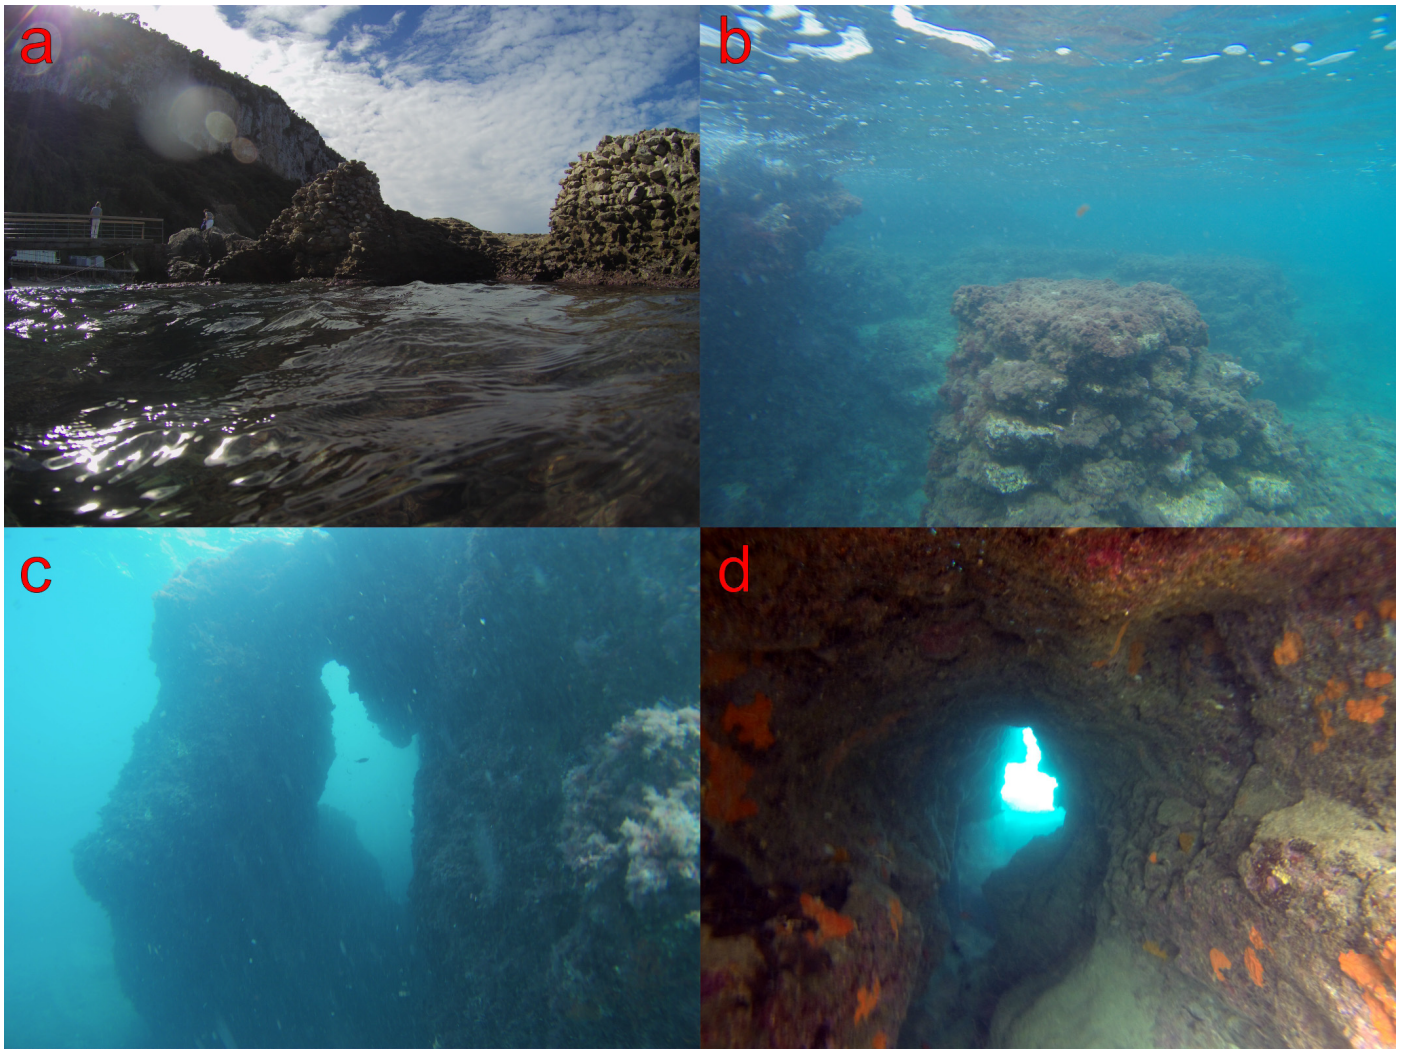
Figure 4 – Emerged (a) and submerged (b) ruins of Palazzo a Mare; c, submerged arch; d, tunnel (photos a-c by C. Stanislao, 2015; photo d by C. Donadio, 2015).

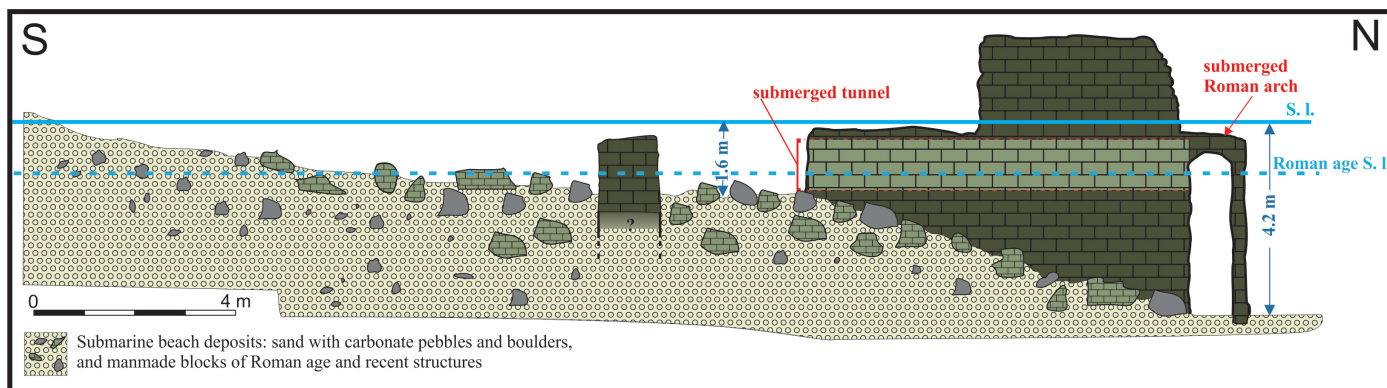
Figure 5 – South-North section of archaeological structures at Roman villa of Palazzo a Mare; depth is in meters bsl.

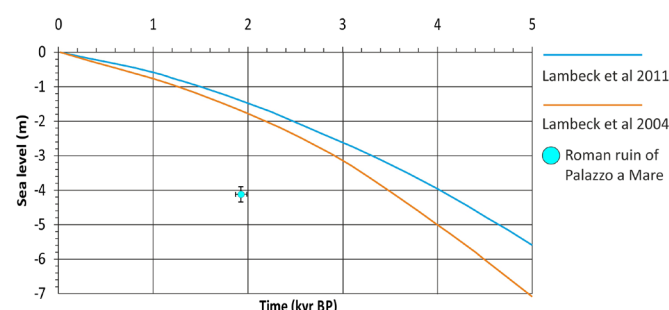
Figure 6 – Position of archaeological markers linked with pre-dicted sea level curve for the site of Campania.

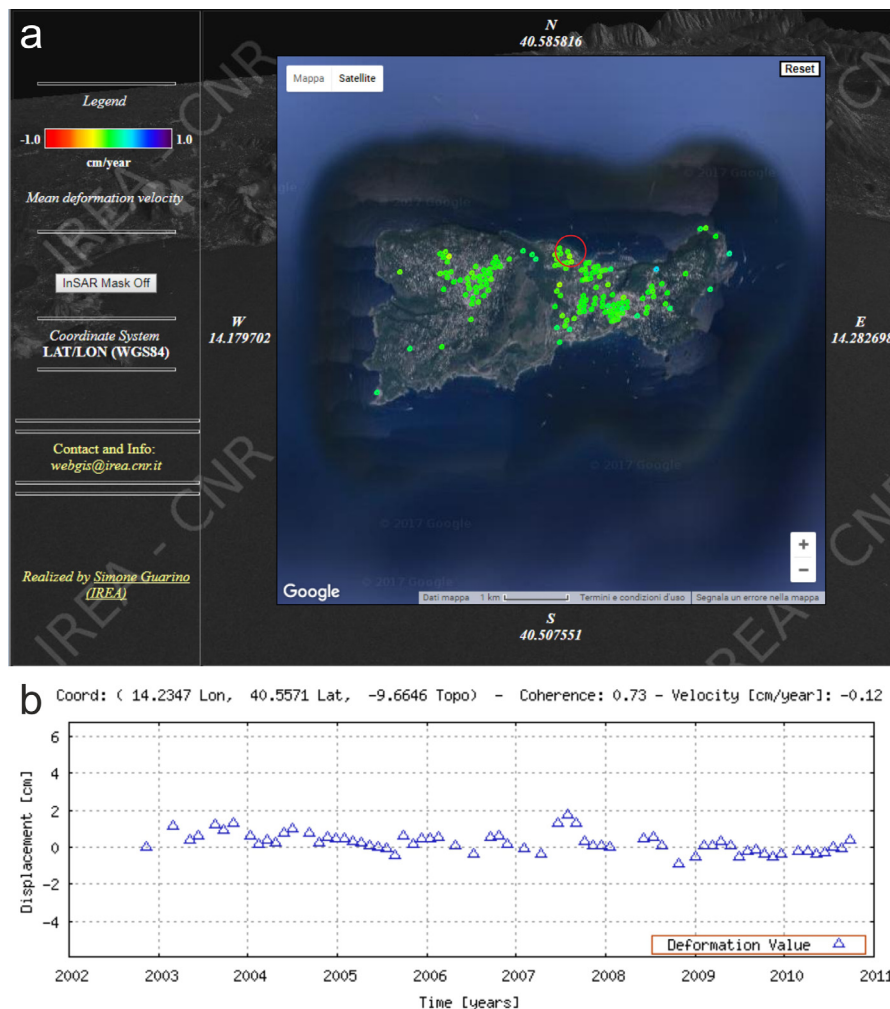
Figure 7 – a, ERS images of Capri Island, from Irea (Istituto per il rilevamento elettromagnetico dell’ambiente); red open circle is the study area; b, InSAR deformation-timeseries.
