# The Stava catastrophic failure of July 19, 1985 (Italy): technical-scientific data and socioeconomic aspects

Lucia Simeoni<sup>1</sup>, Giovanni Tosatti<sup>2</sup>, Graziano Lucchi<sup>3</sup>, Michele Longo<sup>4</sup>

*On July 19, 1985 at Stava near Tesero (Trento Region, northern Italy), two impoundments collapsed, causing the death of 268 people and the destruction of many buildings. The two adjacent basins were constructed for the decantation and storage of fine-grained waste material (tailings), which was pumped from a nearby fluorite mine. The consequences of the failure was a vast mudflow that found its way downstream along the Stava valley. The failure occurred as a result of the collapse of the upper basin, which overwhelmed the lower basin. The mudflow continued down the valley destroying many houses in the village of Stava, eventually reaching Tesero, where more property was destroyed or severely damaged. The disaster in the Stava valley was one of the most tragic of its kind. With its high toll of lives lost and over 133 million euros in damage, it was one of the worst industrial catastrophes anywhere in the world. This paper examines the technical errors, shortco

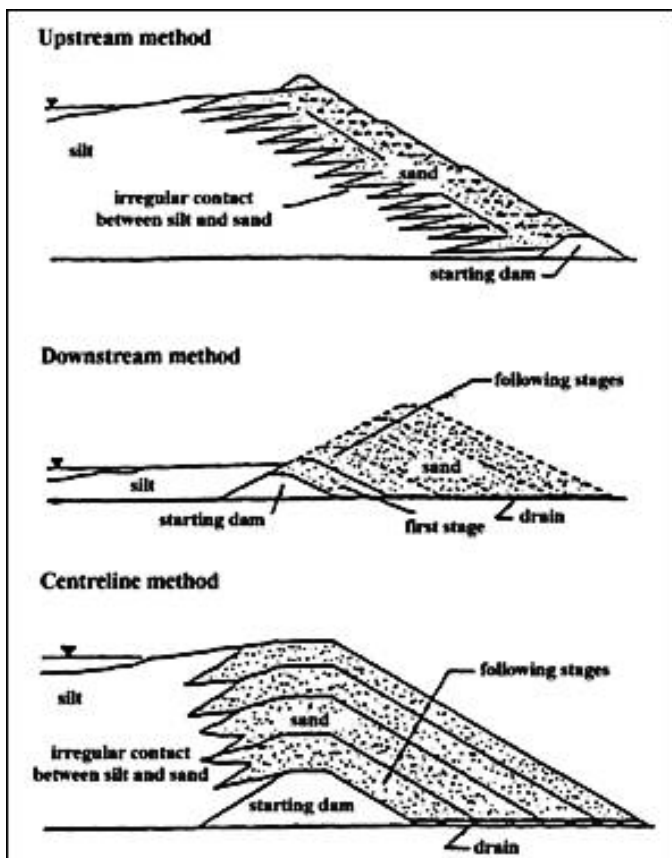
Figure 6 – Construction methods of tailings dams (after Colombo, and Colleselli 2003).

the light of the monitoring results and stability analyses. Raised embankments can be constructed using upstream, downstream, or centerline methods (Fig. 6). With the upstream method, the embankment axis moves backwards and the beach that develops during the deposition of the tailings becomes the foundation of the next dam. With the centerline method, the coarse part of the tailings is placed on both the beach and the downstream face. The upstream method was used in Stava to raise the embankments of both the lower and the upper basins. For the lower basin (built from 1961 to 1971), it was used alternately to the centerline method, while for the upper basin (built from 1969 to 1985) the upstream method was adopted after an initial construction stage using the centerline method (Colombo, and Colleselli 2003). It follows that initially the upper basin was partially founded on the inner, and then finer, part of the tailings of the lower basin (Fig. 4).
